Museum Fire Sediment Reduction Project

Sediment Budget Analysis

January 2022

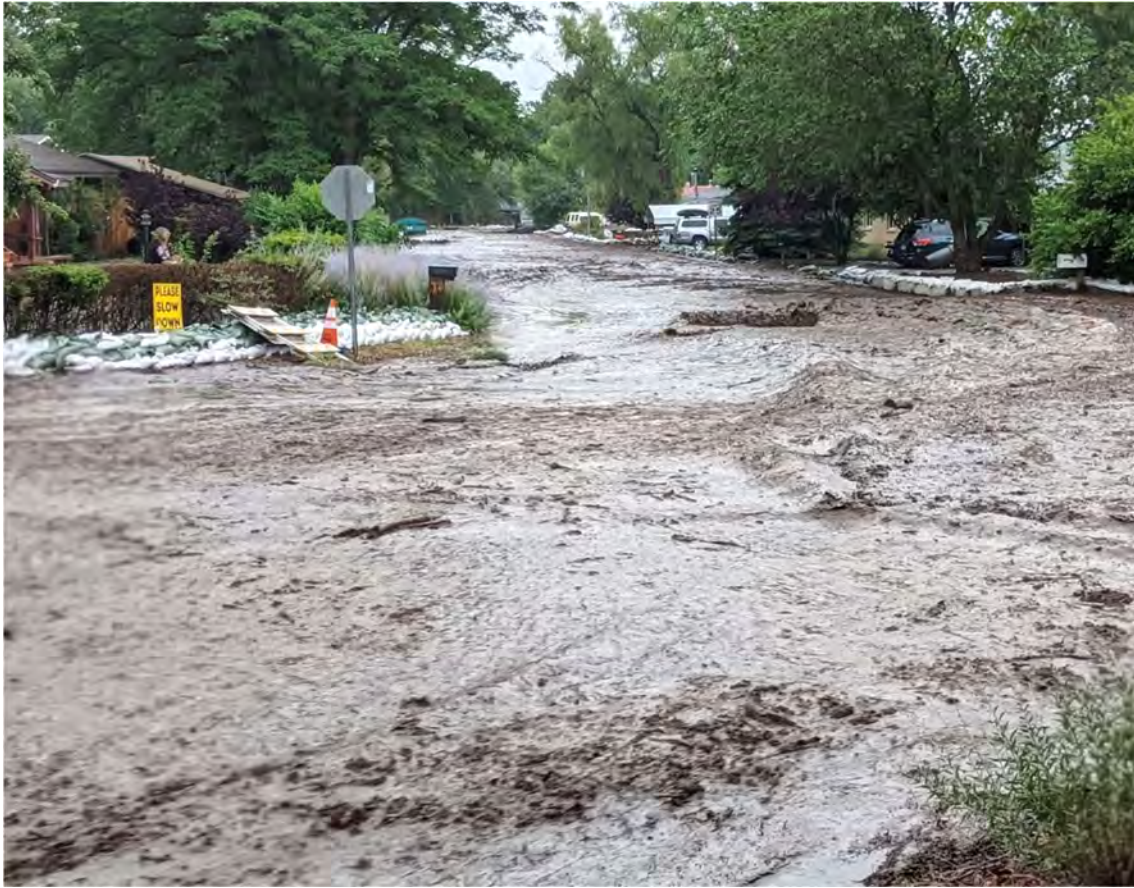
Figure 2. 2021 flooding at Linda Vista and Grandview Drives just below the Paradise neighborhood.

The Museum Fire burned in August 2019. For the duration 2019 and 2020, the Flagstaff region saw well-below normal amounts of winter snow and summer monsoonal rain with little to no post-fire impacts. Initial flooding occurred during the above average 2021 summer monsoon season, resulting in debris flows in the upper watershed and higher than normal surface water flows in downstream areas. As the post-fire impacts changed the upper watershed, vast amounts of downstream sedimentation and flooding resulted within residential areas. Existing drainage features and channels were overwhelmed with post-fire sedimentation and flooding was widespread (Figure 2).

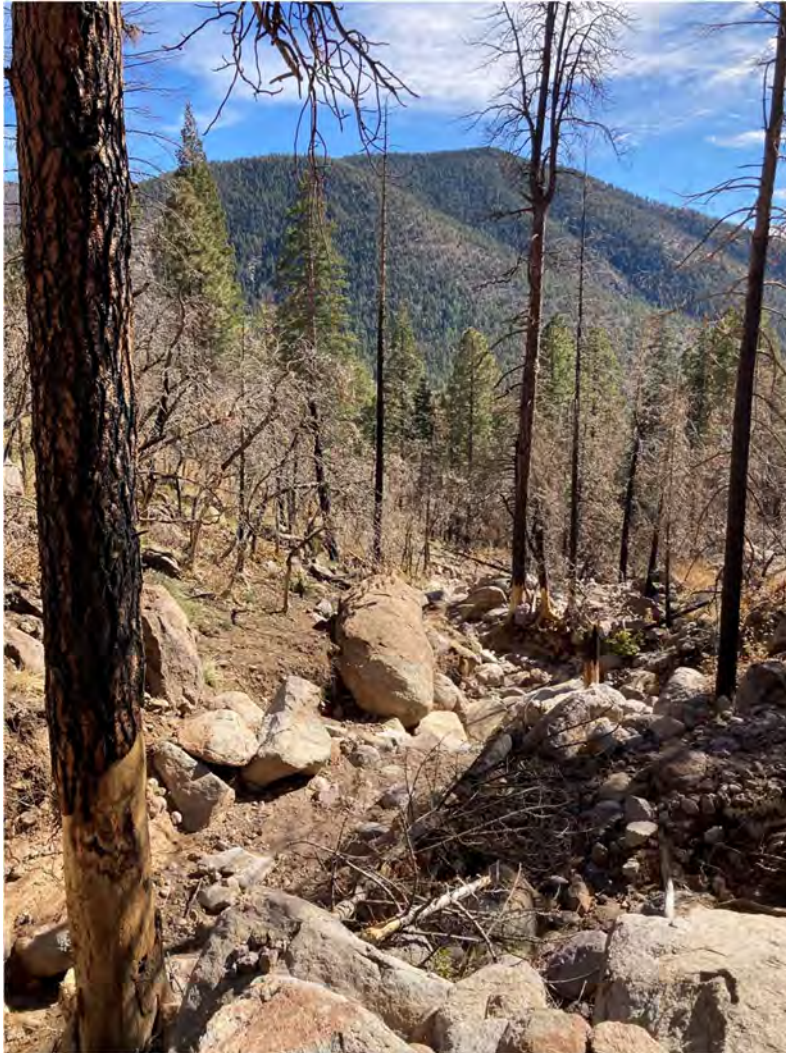
Figure 3. Burned watershed, altered channels and hillslopes in the West Tributary below Dry Lake Hills.

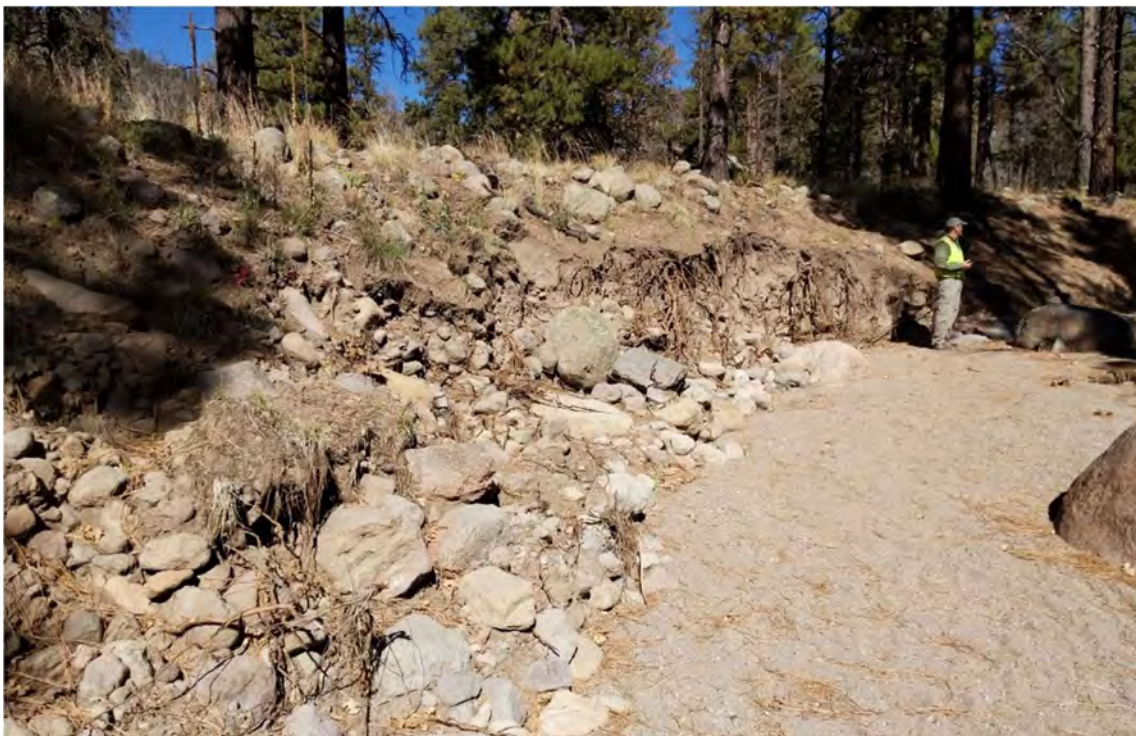
Figure 4. NCD surveyors completing the BEHI analysis on a typical channel along Spruce Ave Wash.

- *Collection of BEHI Data-* To qualitatively evaluate all eroding channels within the Museum Fire watershed, bank erosion hazard index (BEHI) surveys were used (Rosgen 2002). During BEHI surveys, data was collected by teams of two NCD field staff on tablets with the MapItFast application, which enables the user to rapidly tabulate and georeference all field data on pre-formatted field forms (Figure 4). Collected data consists of channel bank height (left and right bank), channel and bank material, length of channel, vegetation and root density, bank slope angle (left and right), valley and stream type classification (Rosgen Stream Classification System 1996), and near bank stress (NBS). MapItFast was used to rapidly map the locations and conditions of all channels in the Museum Fire watershed. Collected field data was manually checked for quality assurance and control using ESRI ArcGIS geospatial software.

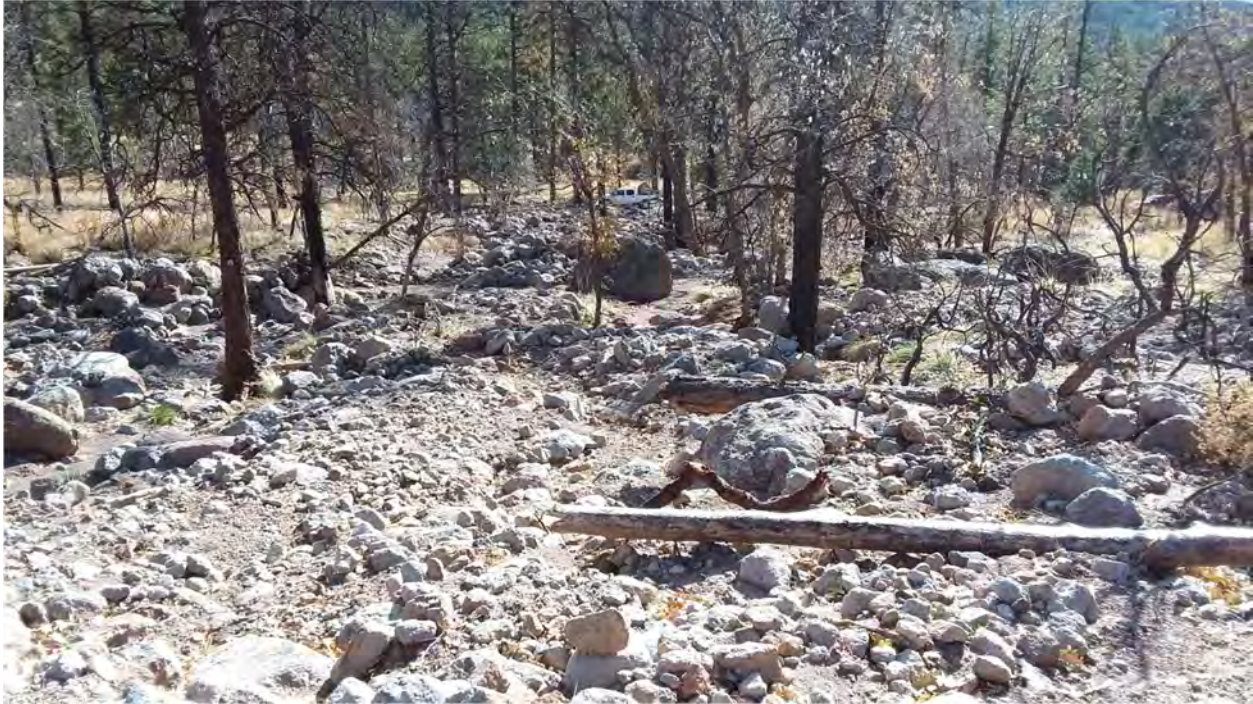
Figure 11. Typical active fan within the Museum Fire area.
Note the debris and sediment aggradation extending valley wide.

In order to reduce sediment transport and actively store sediment within channels several conditions must be met. Primarily the valley containing the channel needs to be broad and relatively flat across the width of the valley. Secondly, the channel within the valley must be wide and shallow (Width to Depth Ratio > 40). There are multiple examples of working fan channels within the Museum Fire area (Figure 11). However, many fans have been incised and damaged as a result of recent flooding (Figure 12). Incised channels within the proper valley type have the potential to be restored to conditions that will enhance sediment storage. This is accomplished by filling in the incised channel to raise the bed of the channel up to a pre-fire flood elevation that forms a wide shallow channel (Figure 13 and Figure 14). The new channel is a wide, flat channel that allows for deposition of sediment and formation of fan features (Figure 15). Considerable volumes of fill are required to fill the incised channel in many cases. Fill is borrowed from the adjacent banks to minimize haul distance and limit the disturbance area. Additionally, trenches can be constructed within the fans that can be used as borrow areas (Figure 16). A trench extends across the entire channel cross-section, forming a deep depression (10-15 ft) with shallow slopes on all sides. The slopes are protected with rock to prevent head cutting. The trench, or borrow pit, is left open to catch excess sediment, providing additional storage.

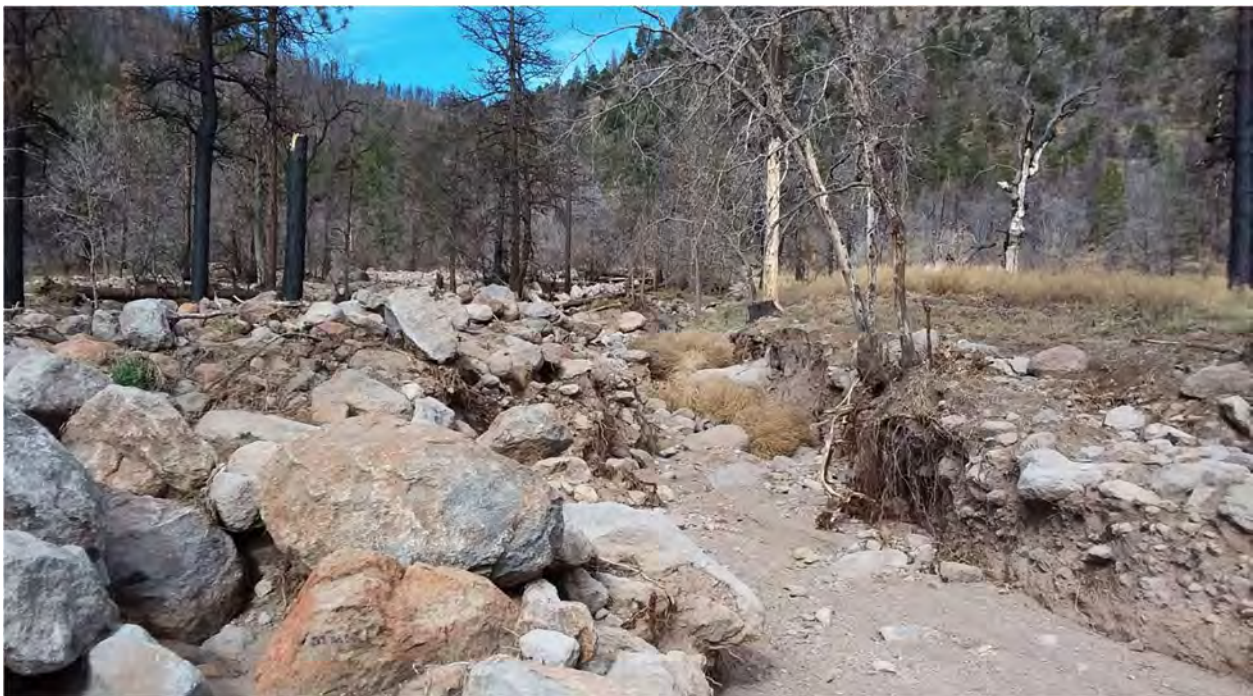
Figure 12. An incising channel in reactivated fan in the Museum Fire watershed.

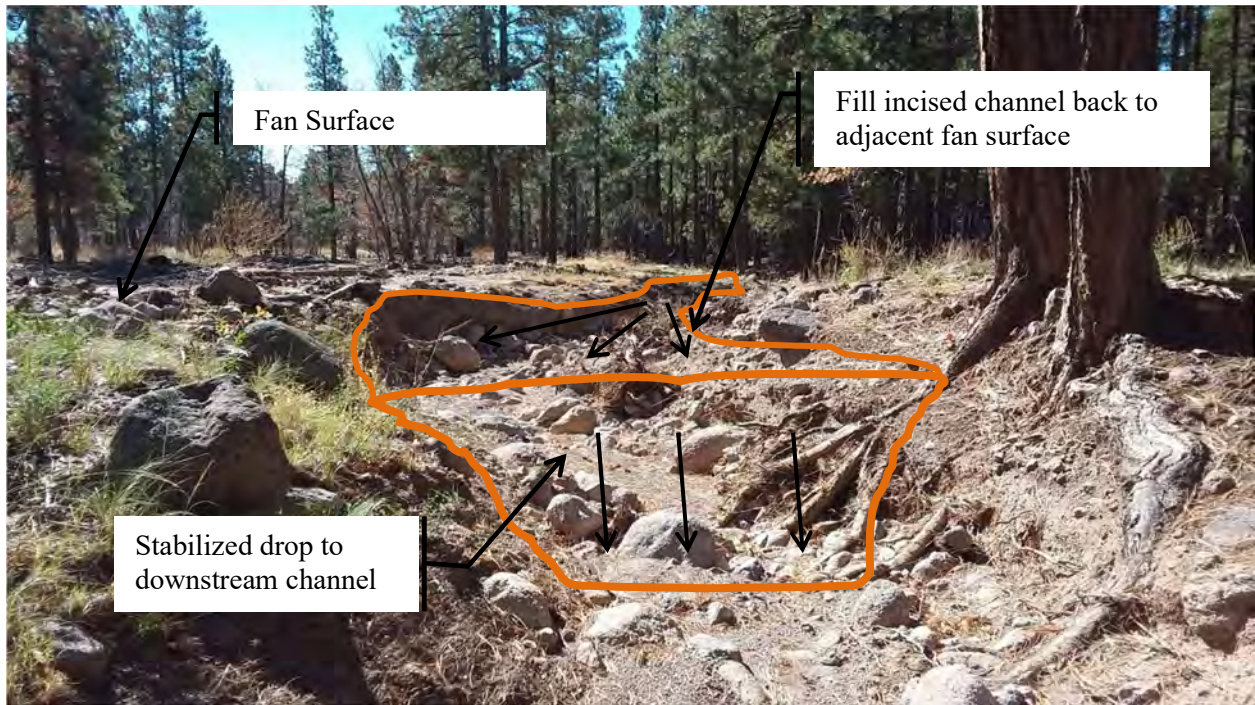
Figure 14. Typical area of fill for construction of over-widened "D" channel.

Orange area shows approximate location of fill material through incised channel.

Over-wide, multi-thread channel cross section is achieved by filling gullied “F” or “G” channel back to original valley floor elevation. Green represents proposed cross section of wide, multithread, flattened channel. Red indicates the existing incised channel.

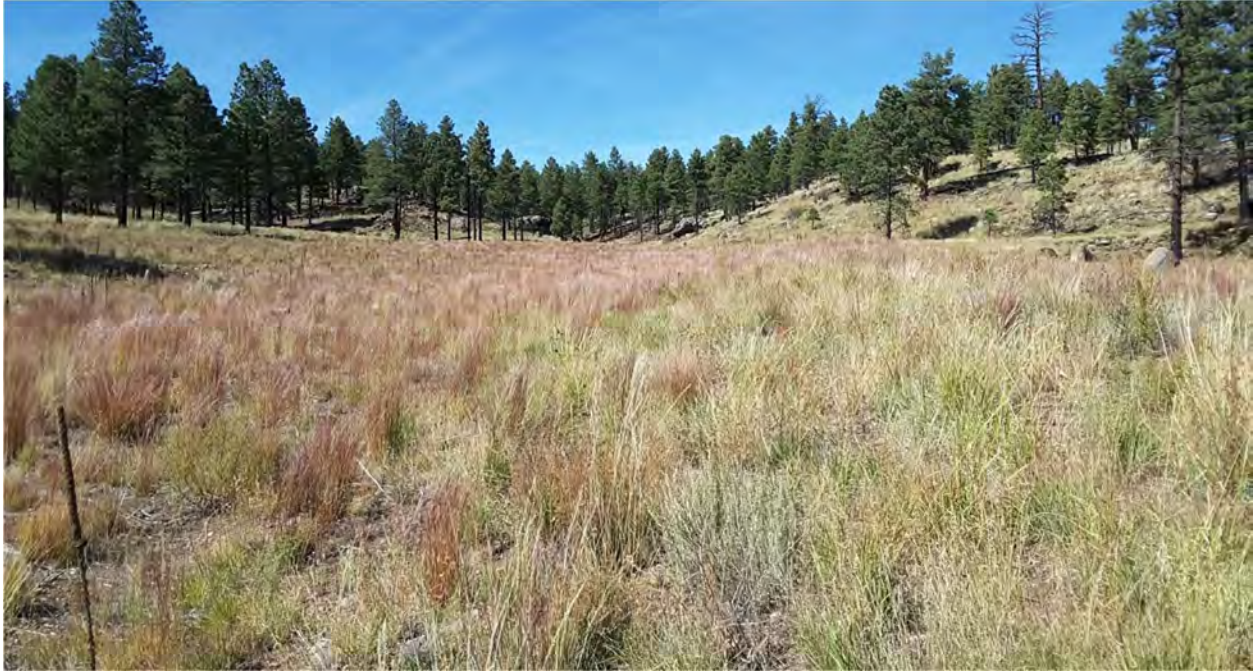
Figure 15. Example of rehabilitated alluvial fan in the Schultz Fire area.

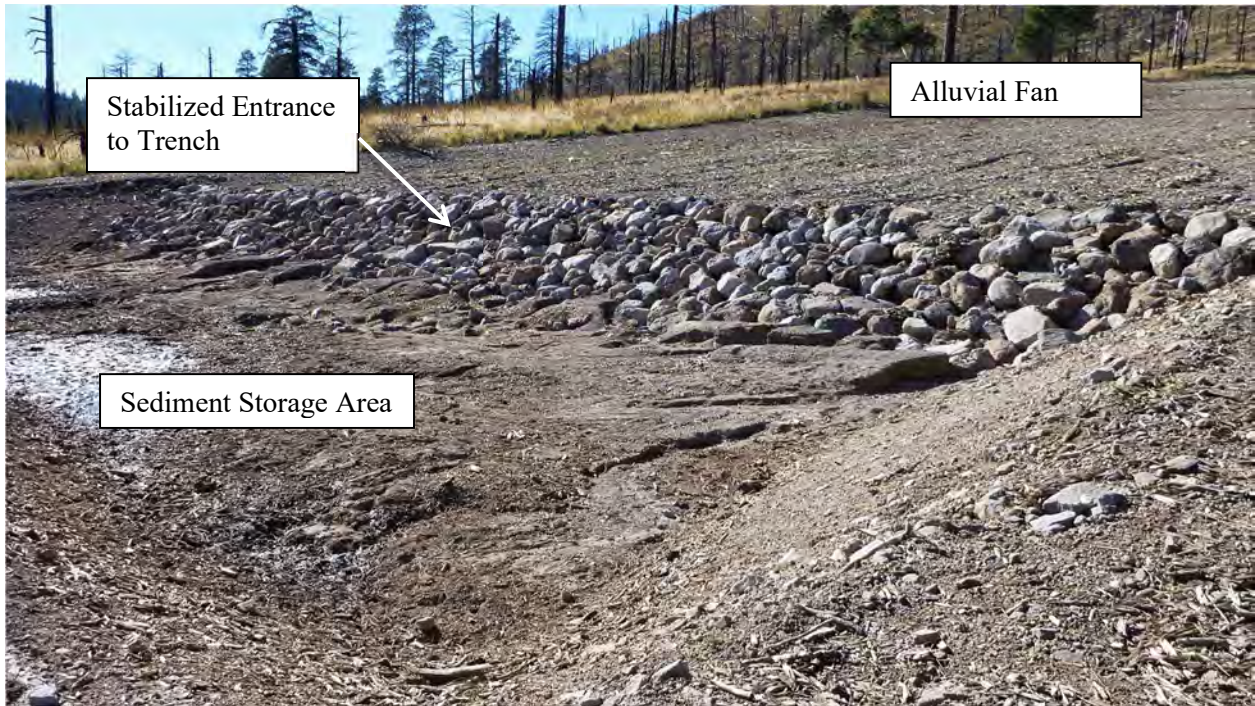
Figure 16. Trench in a fan in the Schultz Fire area.

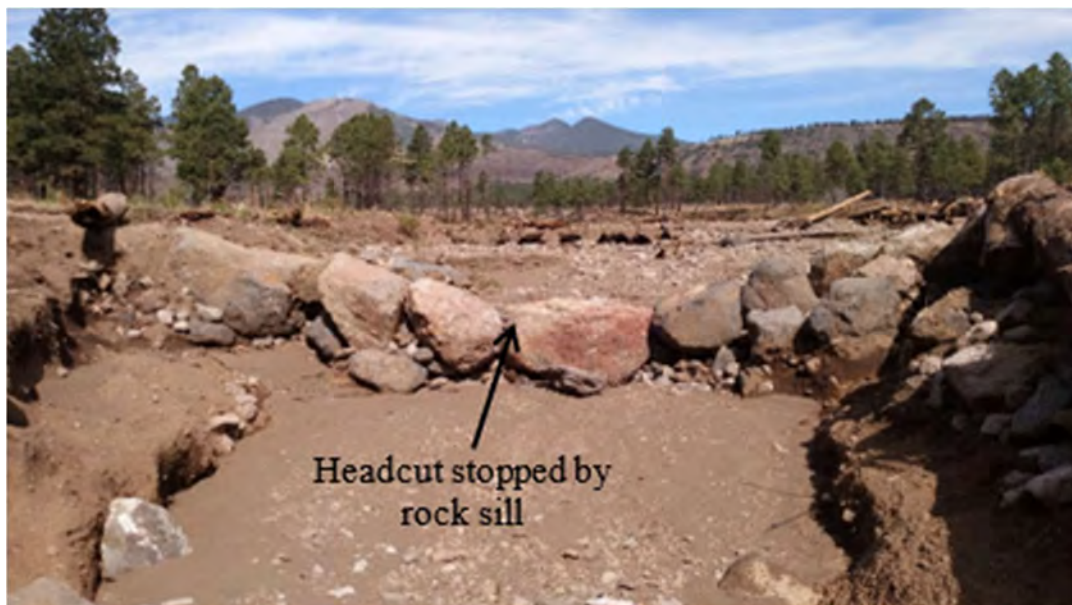
Figure 17. Rock sill maintaining upstream fan gradient in Shultz Burn area.

This particular rock sill is on the Shultz Fire watershed and shown following a 1000-year storm event on the upstream watershed in which it held grade, despite flows well in excess of the design storm event.

Sills are used to stabilize fans and consist of a line of rocks or logs buried at grade, perpendicular to the direction of flow across the entire width of the fan (Figure 17 and Figure 18). The purpose of a sill is to prevent rilling on the fan surface from developing headcuts through the fan. These structures are installed in series along the fan surface with spacing determined by the fan slope. Logs, if used, will be sourced on site from trees that must be removed for fan grading. It should be noted log sills are not a permanent grade control and will rot out within 3-6 years.

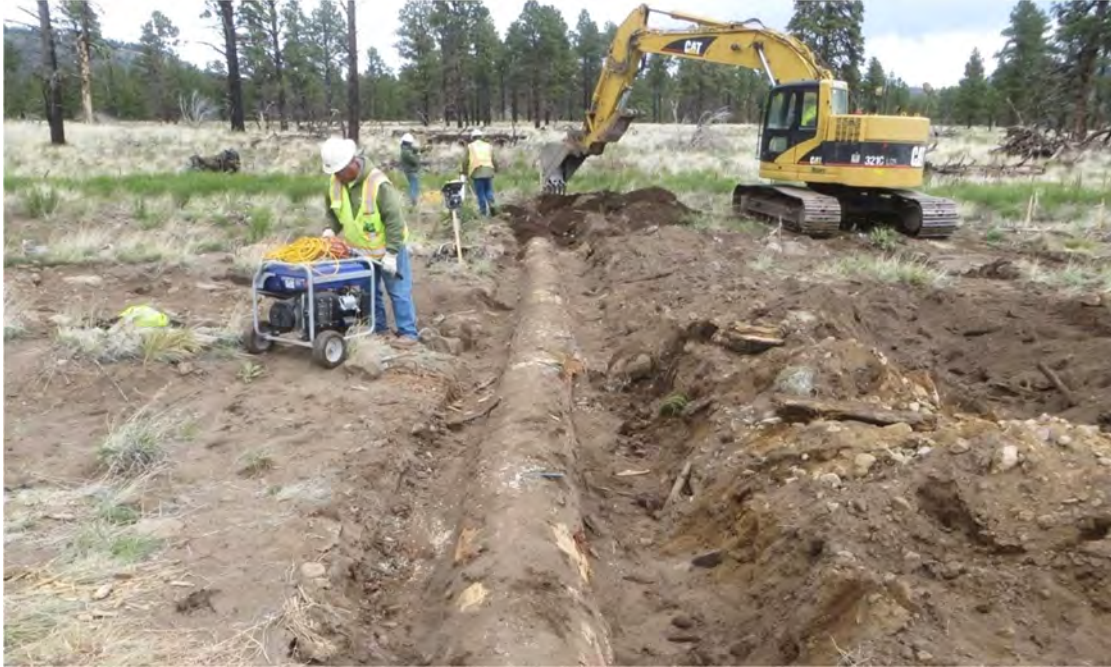
Figure 18. Log sill installation on fan surface in Schultz Burn area.

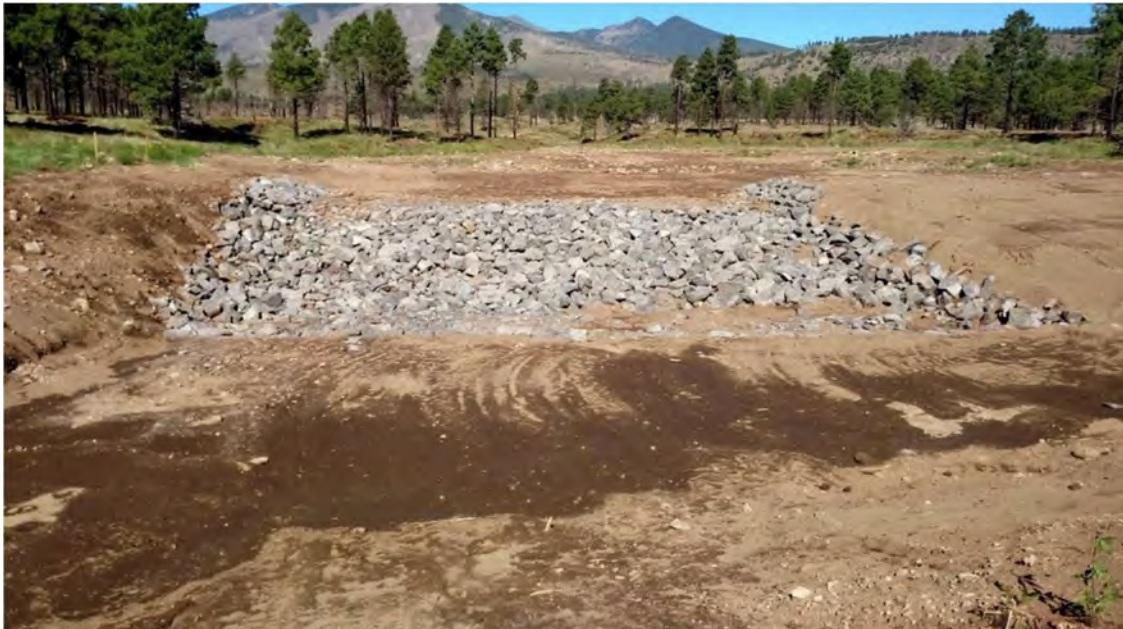
Figure 19. Rock chute at terminal trench in Schultz Burn area.

Rock chutes are used to drop flow over large, short grade breaks and are sized to contain large flow events (Figure 19 and 20). Rock chutes are a pad of graded rip rap, sized to resist shear stresses over the grade break with a “pool” at the downstream end to reduce velocities. Rock chutes are placed at the terminal trench at the downstream end of the fan structures and at grade breaks in channels to prevent headcutting.

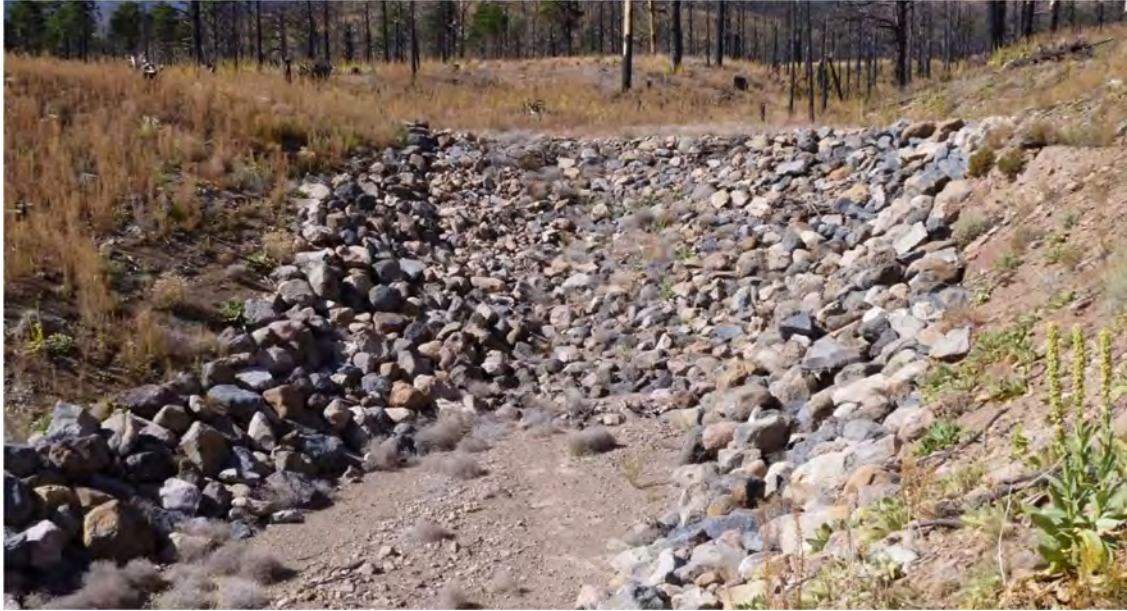
Figure 20. Rock chute in a channel at grade break caused by Schultz Pass Rd.

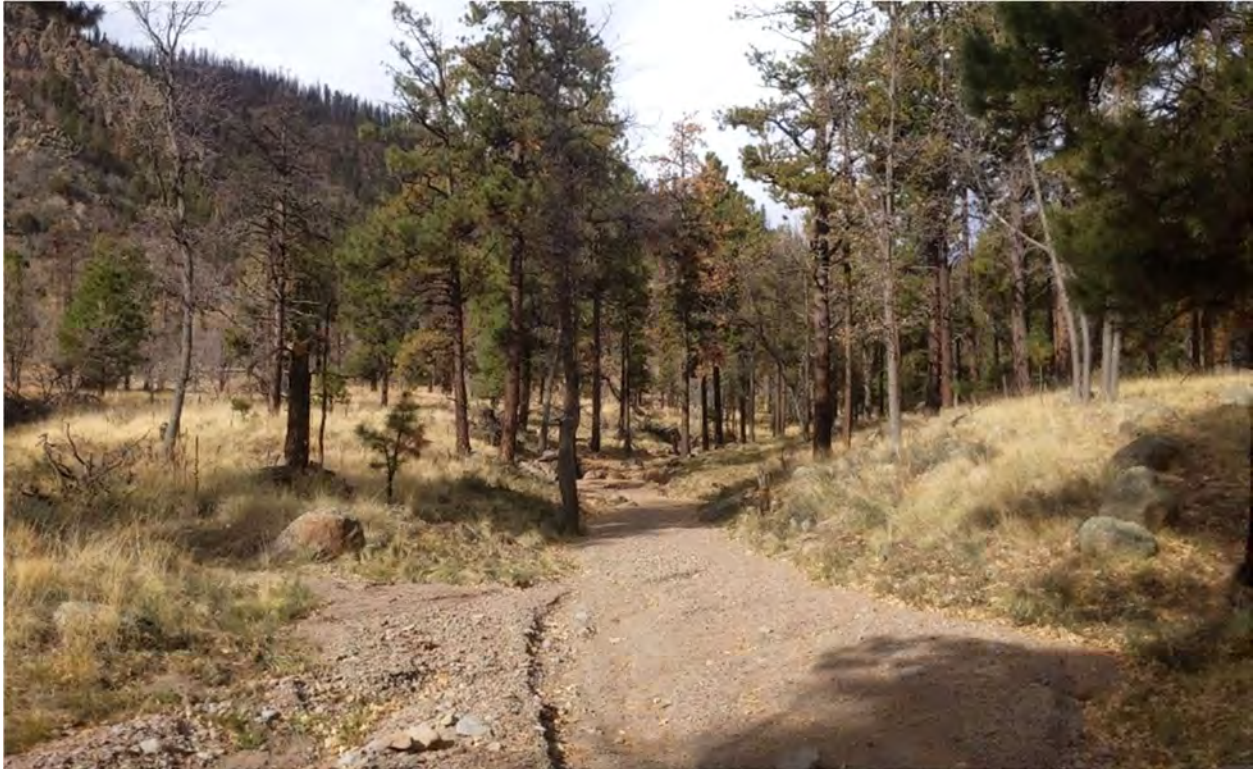
Figure 23. Existing stable single thread channel after high flow event.

Stable channels in the fire area provide a model for design of restored channels. Note stable bank slopes and no sediment sourcing from this reach even after multiple large events passed through channel from burn area upstream.

In areas with narrower valley floors that will not support aggrading channels, the best solution is to convert incised, poor condition channels (Rosgen F and G types) to single thread, stable channels (Rosgen B type) (Figure 23). This is accomplished by cutting away the steep banks and creating a less incised channel, with a small floodplain surface at bankfull stage (Figure 24 and Figure 25). The new channel will need to be built with natural roughness features that help dissipate energy. These features are built of logs or large boulders and form a pool drop system to dissipate energy and help keep the newly formed bed intact. However, the key element is the formation of a bankfull stage floodplain to lower velocities and shear at higher stages.

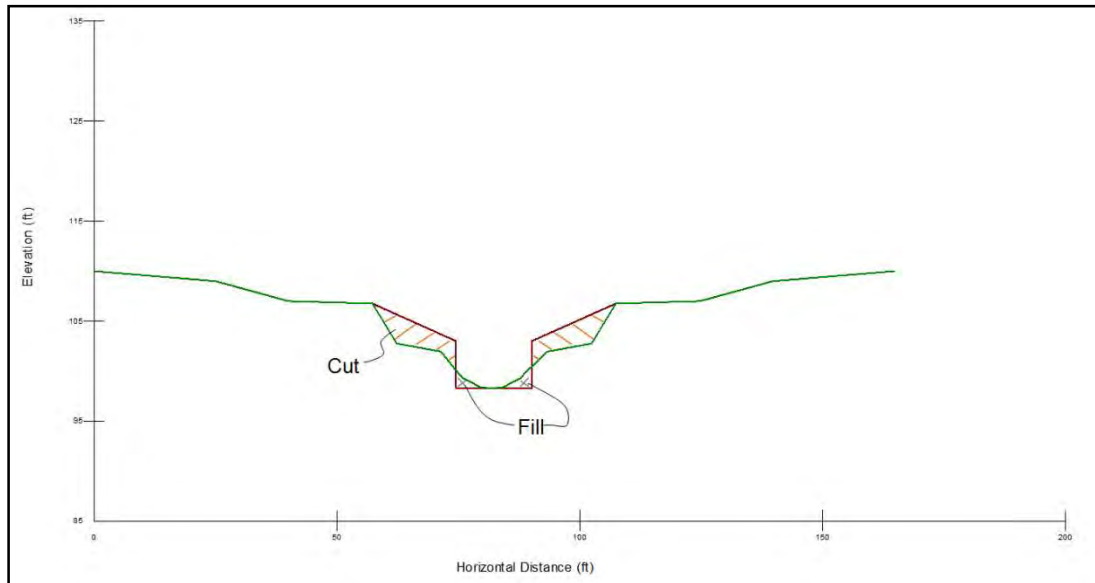
Figure 24. Typical cut and fill for single thread channel conversion.

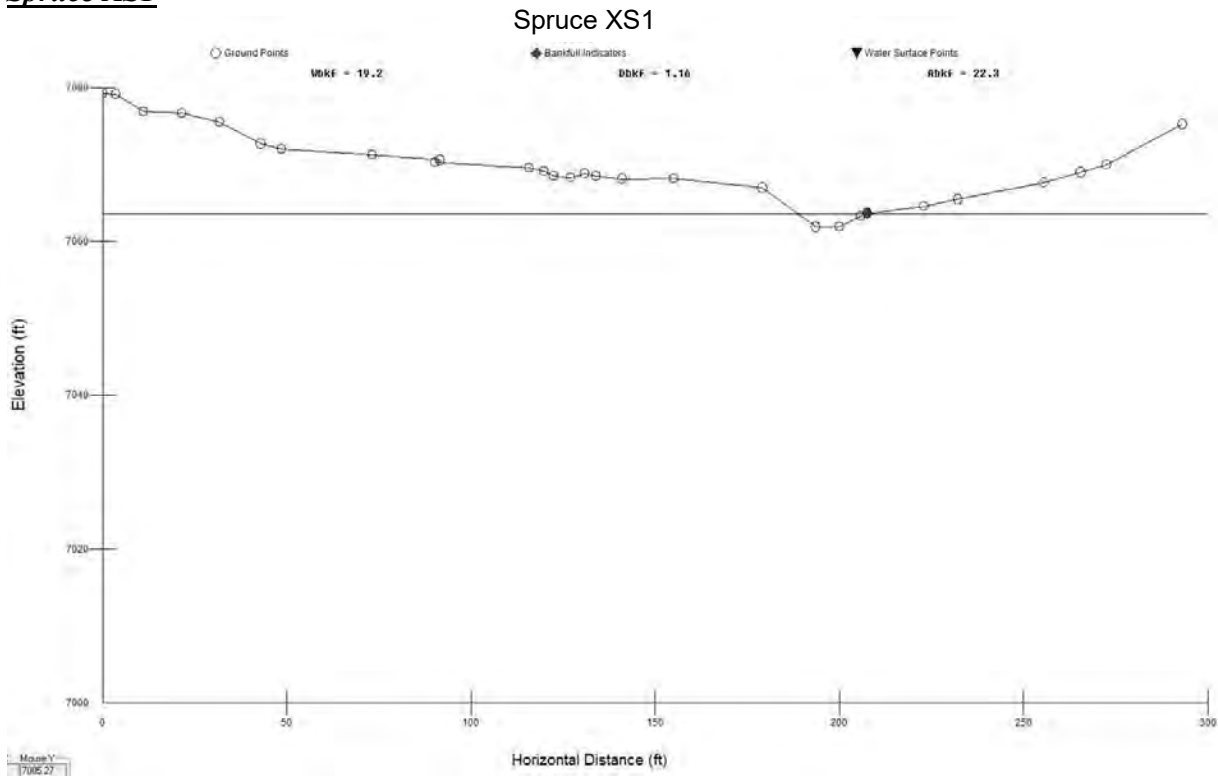
Spruce XS1

Figure 3. Spruce cross section (XS) 1 surveyed at the upstream end of the Spruce Wash just below private lands (Lockett Ranches).

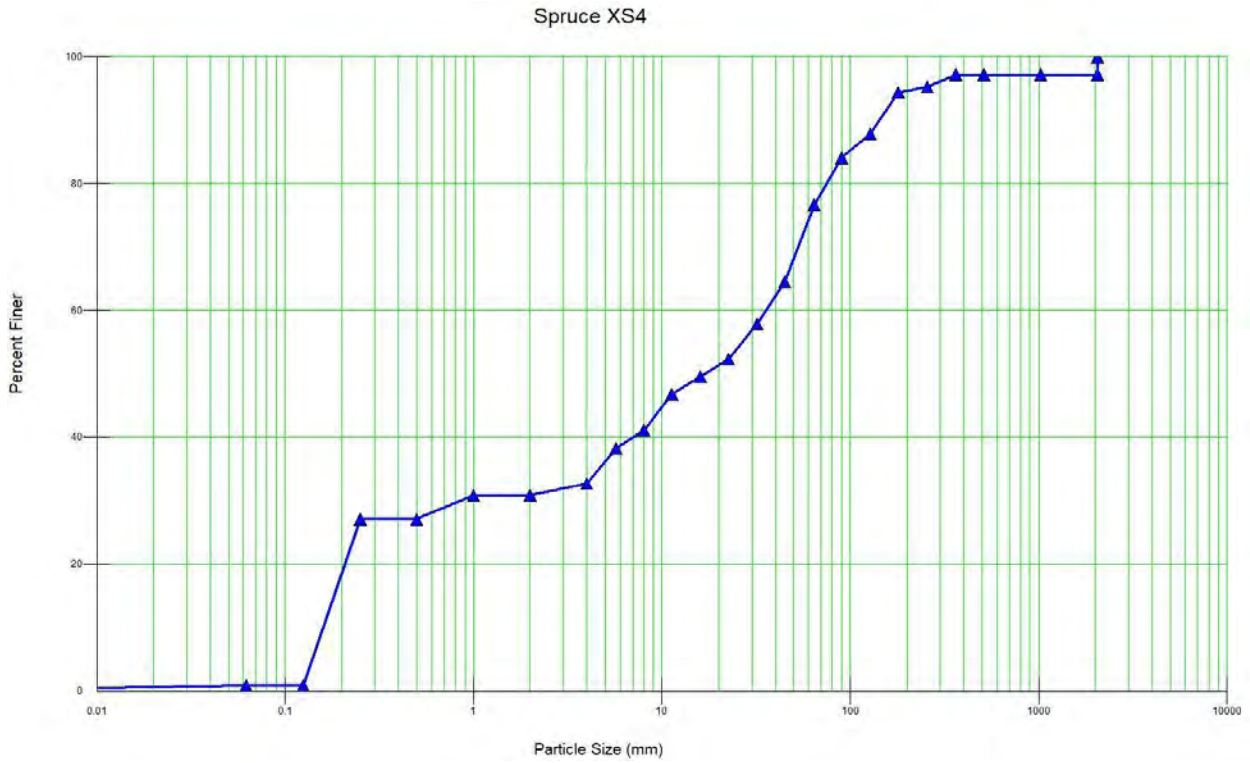
Figure 13. Representative Pebble Count at Spruce XS 4, D50 = 17.1 mm.

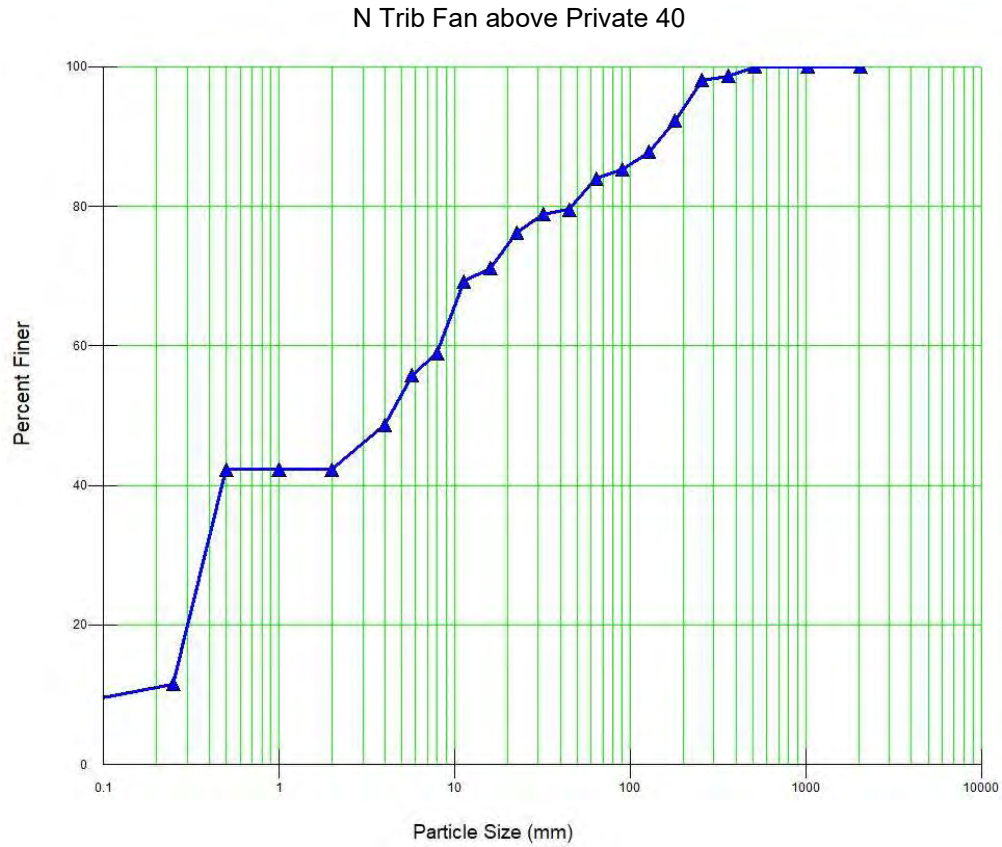
Figure 27. North Tributary Fan above Private 40 pebble count. D50 = 4.3 mm.

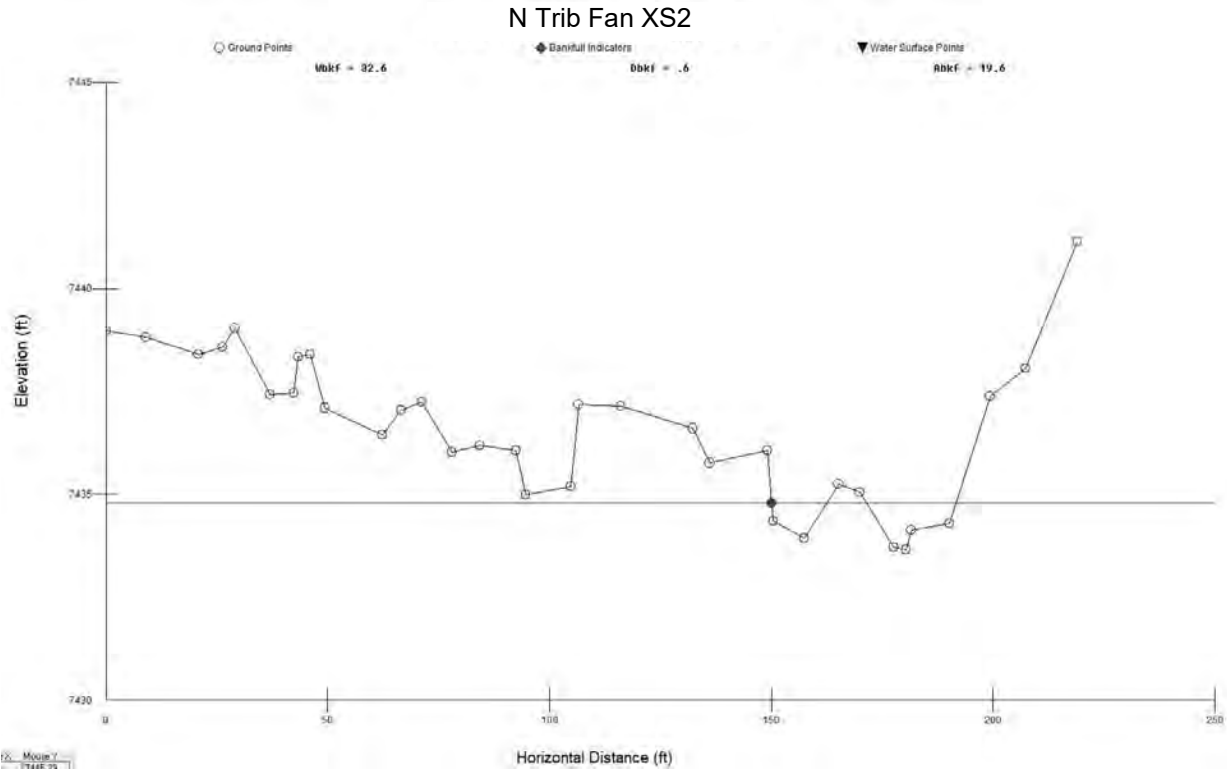
Figure 42. Representative cross section North Tributary Fan XS2.

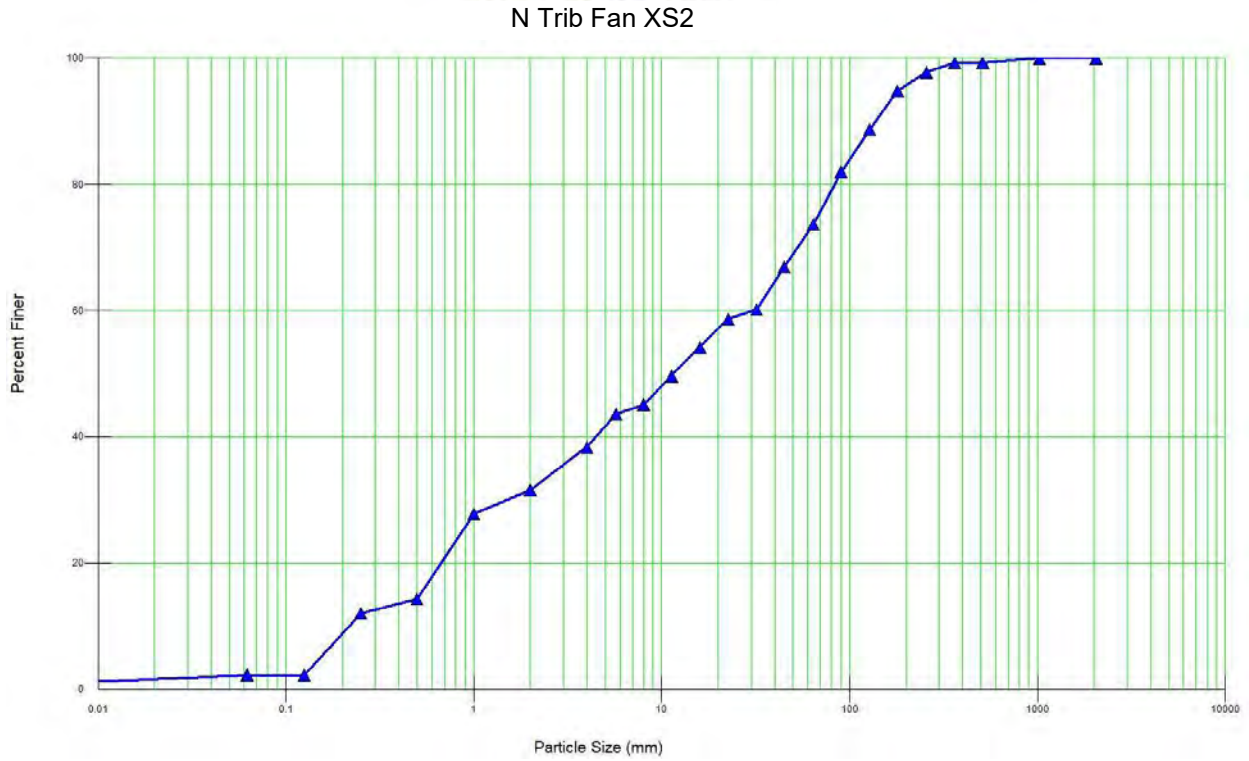
Figure 44. Representative pebble count at North Tributary Fan cross section 2.

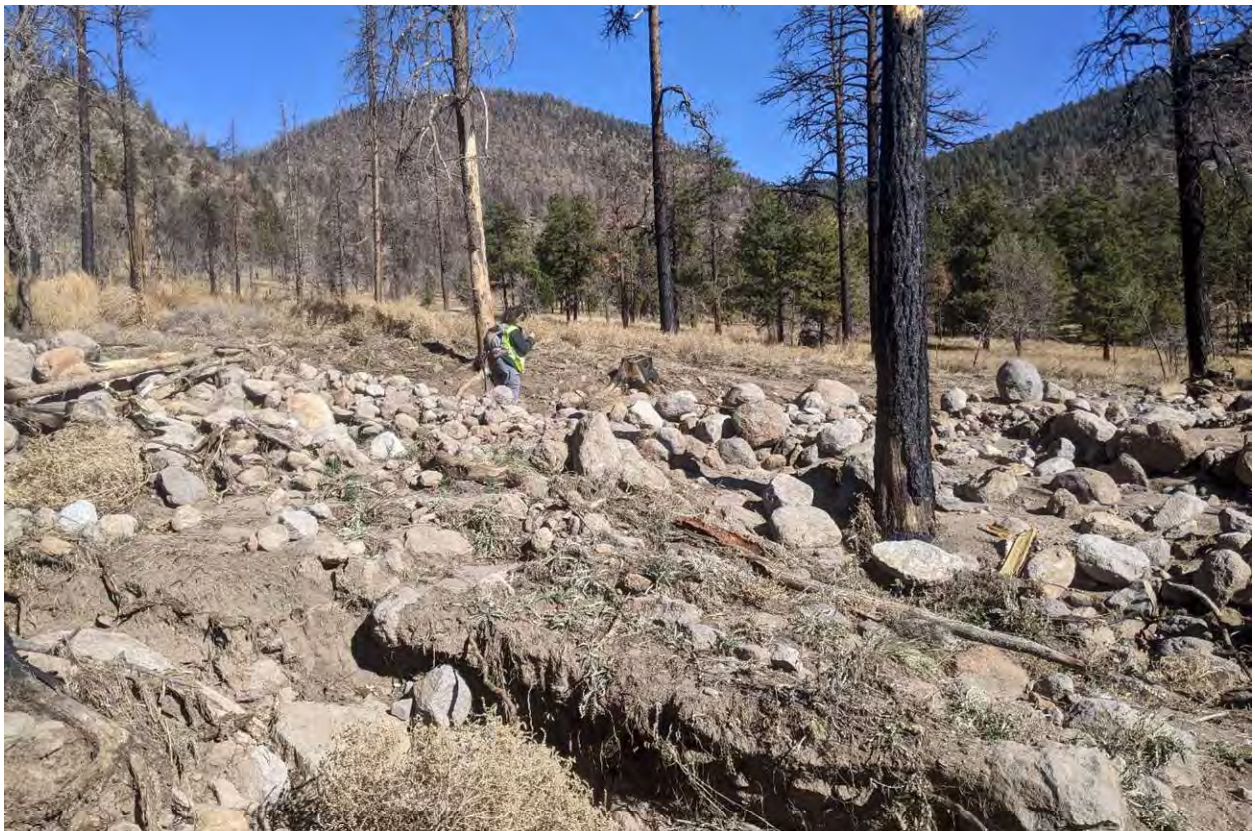
Figure 117. Upper West Tributary XS2 on fan.

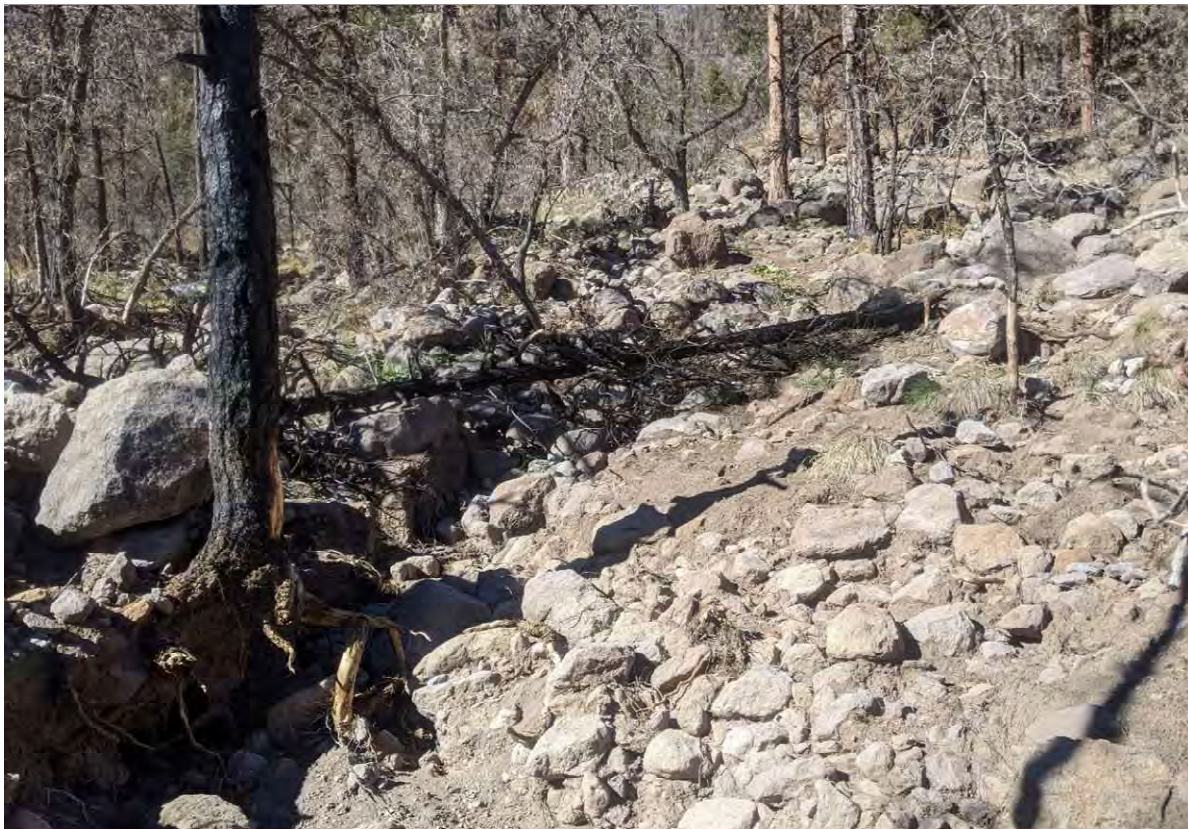
Figure 121. Upper West Tributary XS3 channel leading into fan.
