Schultz Fire and Flood Assistance Area

Sediment Analysis Refinement & Reduction Options Final Report

**Natural
Channel
Design, Inc.**

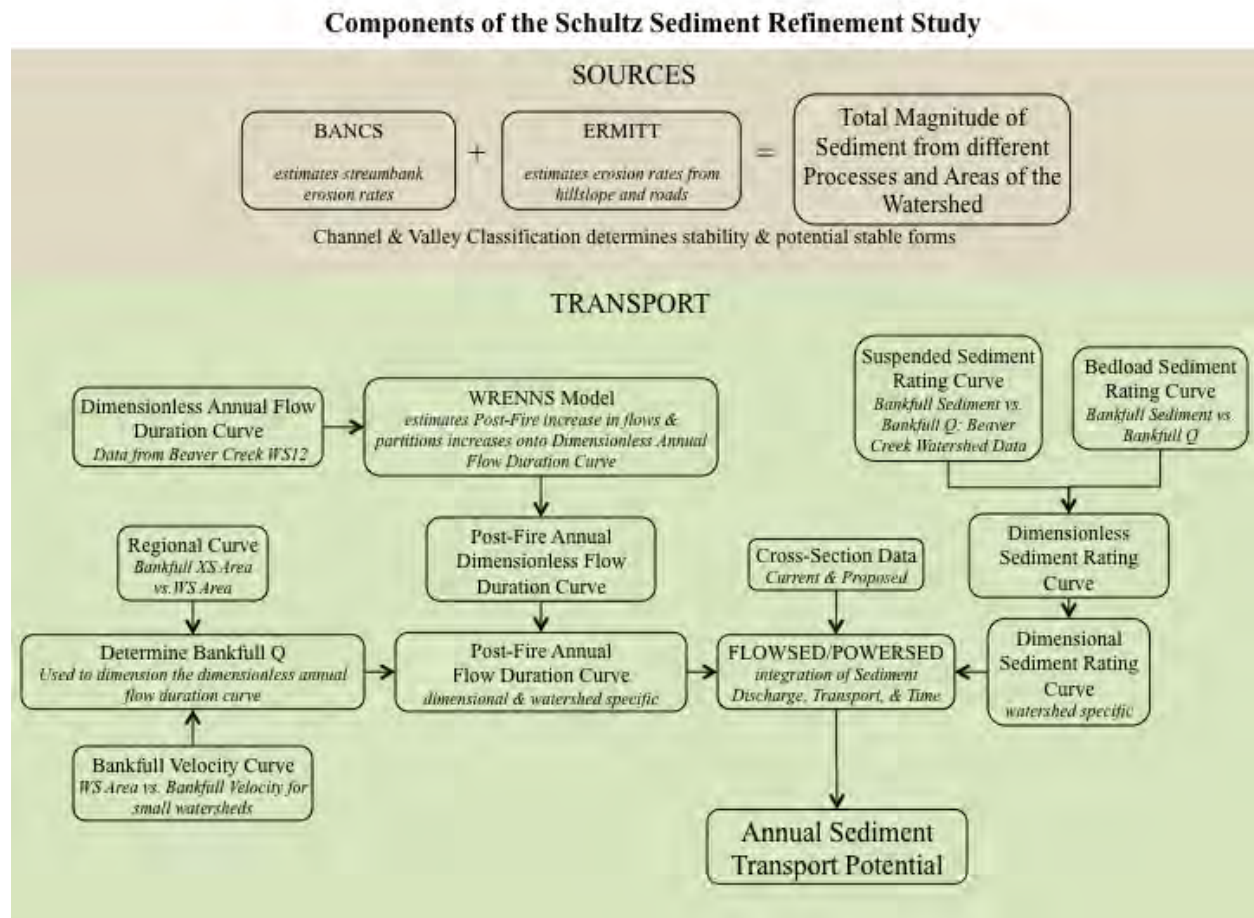
Figure 1. Flow chart of study design and data sources.

The process, location and magnitude of sources were estimated using the BANCS and ERMITT models to estimate bank erosion, hill slope erosion and road erosion. Sediment transport potential under current and proposed conditions was modeled using the Flowseed / Powered model with inputs derived from WRENNS model and other sources.

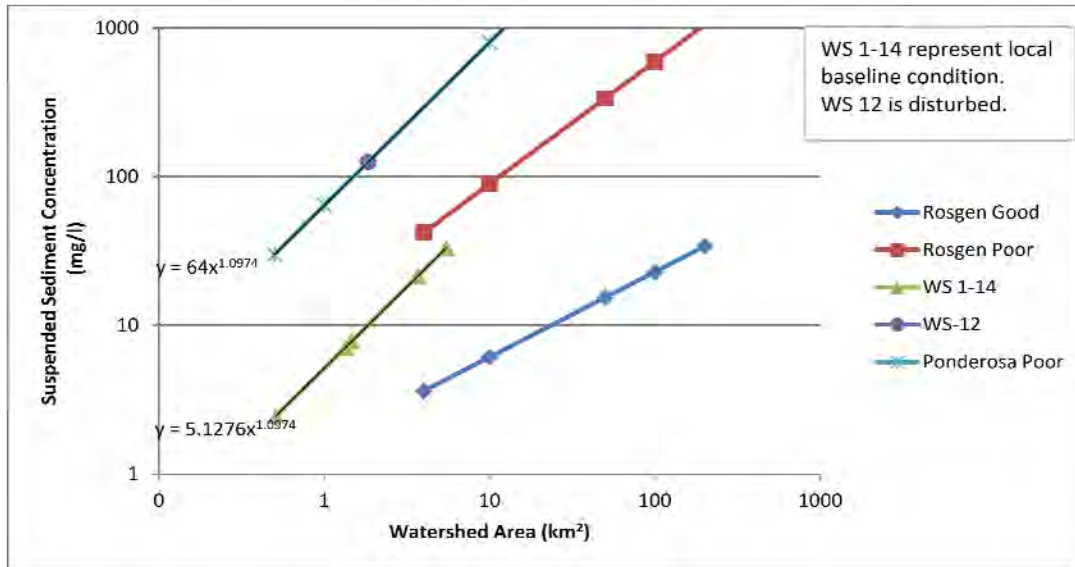
Figure 5. Regional bankfull suspended sediment curve.

Regional curve was developed from Beaver Creek Experimental Watershed data for good and poor condition watersheds. Southern Colorado regional curves developed by David Rosgen are shown for reference.

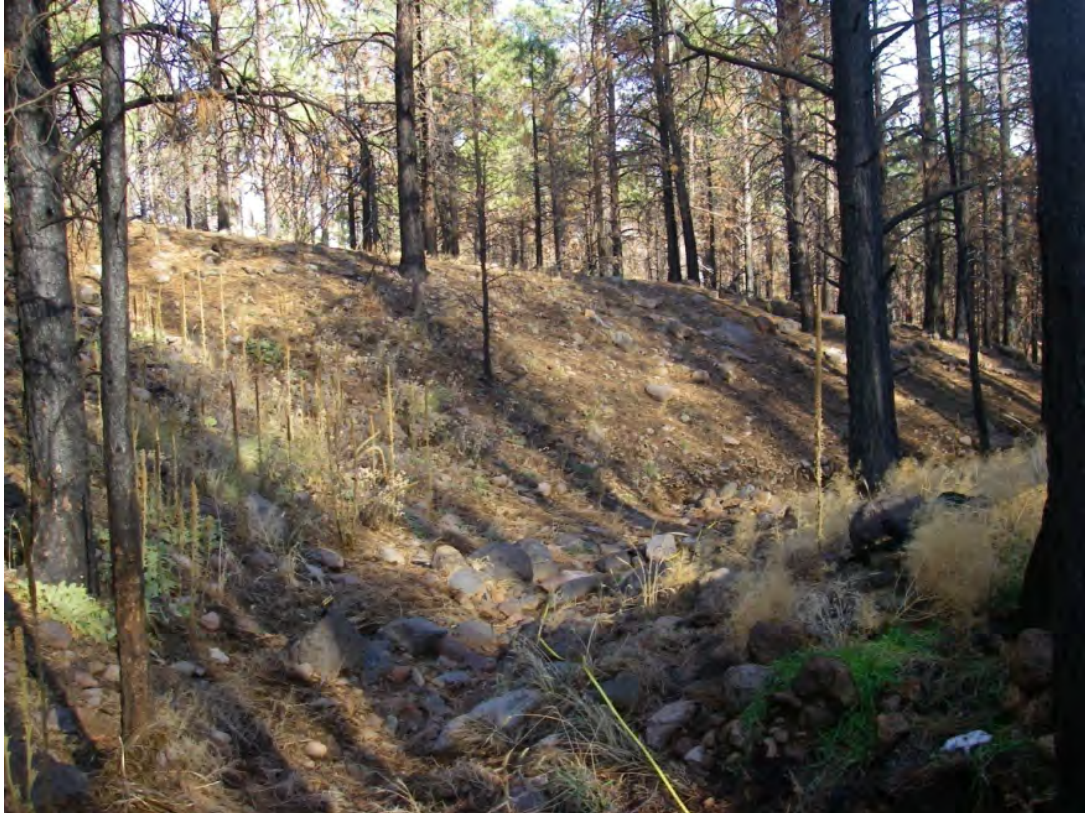
Figure 14. Existing stable single thread channel.

Stable channels in the fire area provide a model for design of restored channels. Note large boulder roughness elements, relatively low flood plain features, and the lack of eroding banks.

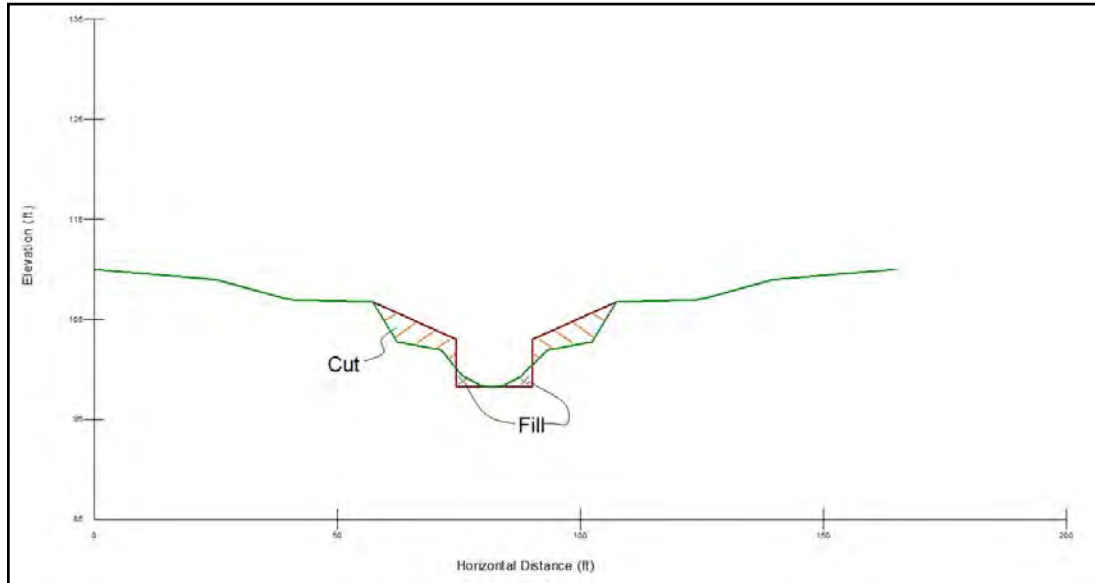
Figure 15. Typical cut and fill for single thread channel conversion.

Overlay of typical design channel (green) on typical incised channel cross section (red) indicates area of cut and fill required to reshape the channel.

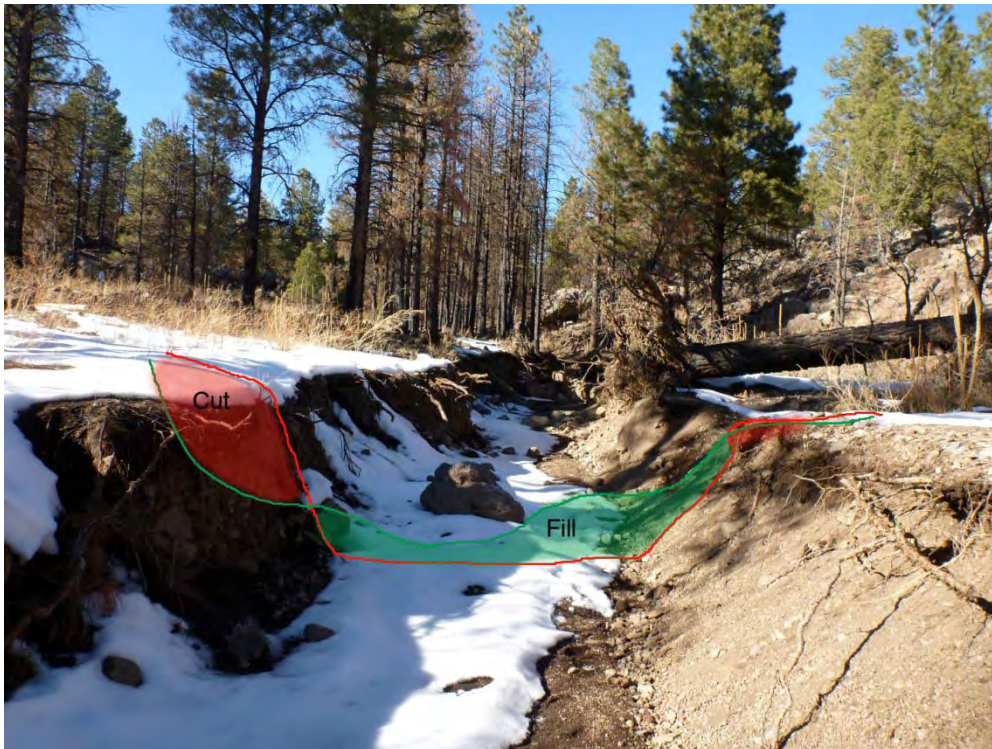
Figure 16. Typical incised channel to stable channel conversion.

In areas with narrower valley floors that will not support aggrading channels, the best solution is to convert incised, poor condition channels (Rosgen F and G types) to single thread, stable channels (Rosgen B type). This is accomplished by cutting away the steep banks and creating a less incised channel, with a small floodplain surface at bankfull stage (Figure 14, Figure 15, and Figure 16). The new channel will need to be built with natural roughness features that help dissipate energy. These features are built of logs or large boulders and form a pool drop system to dissipate energy and help keep the newly formed bed intact. However the key element is the formation of a bankfull stage flood plain to lower velocities and shear at higher stages.

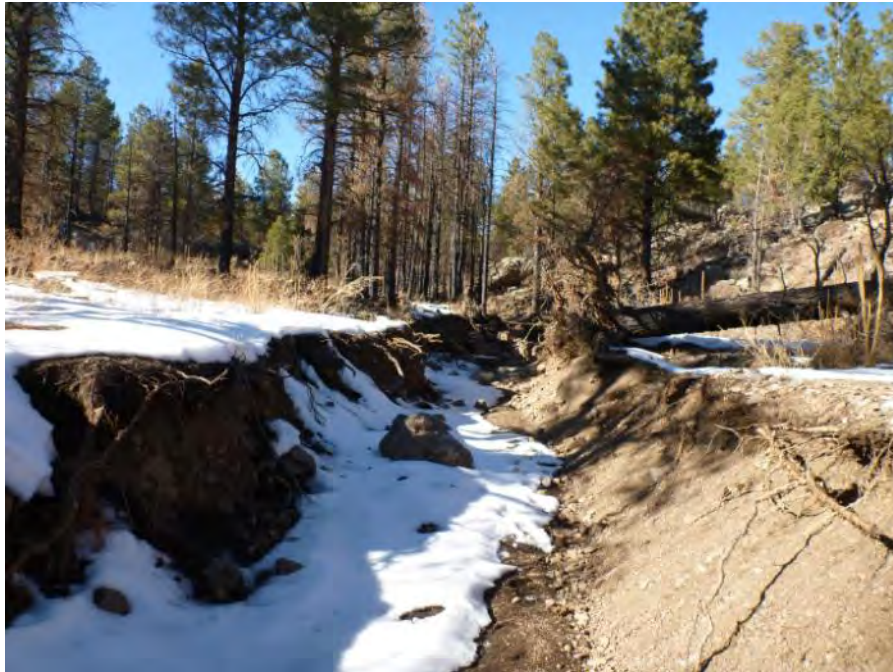
Figure 18. Representative photograph of the surveyed reach at the mouth of the Lenox watershed.

This portion of the Lenox watershed contains a recently incised channel due to increased runoff. The stability of channel reaches in this area is poor due to degradation, and active incision. This poor rating of indicates a potential for accelerated increase in flow-related sediment based on increased post-fire channel flow. At the survey location the valley type is transitioning from Type II to a Type III. The channel slope within the survey is 4.5 % with a bankfull cross-sectional area, determined by local curve, of 21.9 ft^2 . The 2.9 mi^2 watershed has a bankfull discharge of $16.5 \text{ MDF}/43.3 \text{ IM cfs}$ at the survey location. The streambank erosion rate is 0.30 tons/yr/ft . The combined bedload and suspended load transport capacity of the current “F” channel is 563 tons/yr . It is expected that the historic or restored “D” channel would have a transport capacity of 130 tons/yr , a 74% reduction over the current condition.

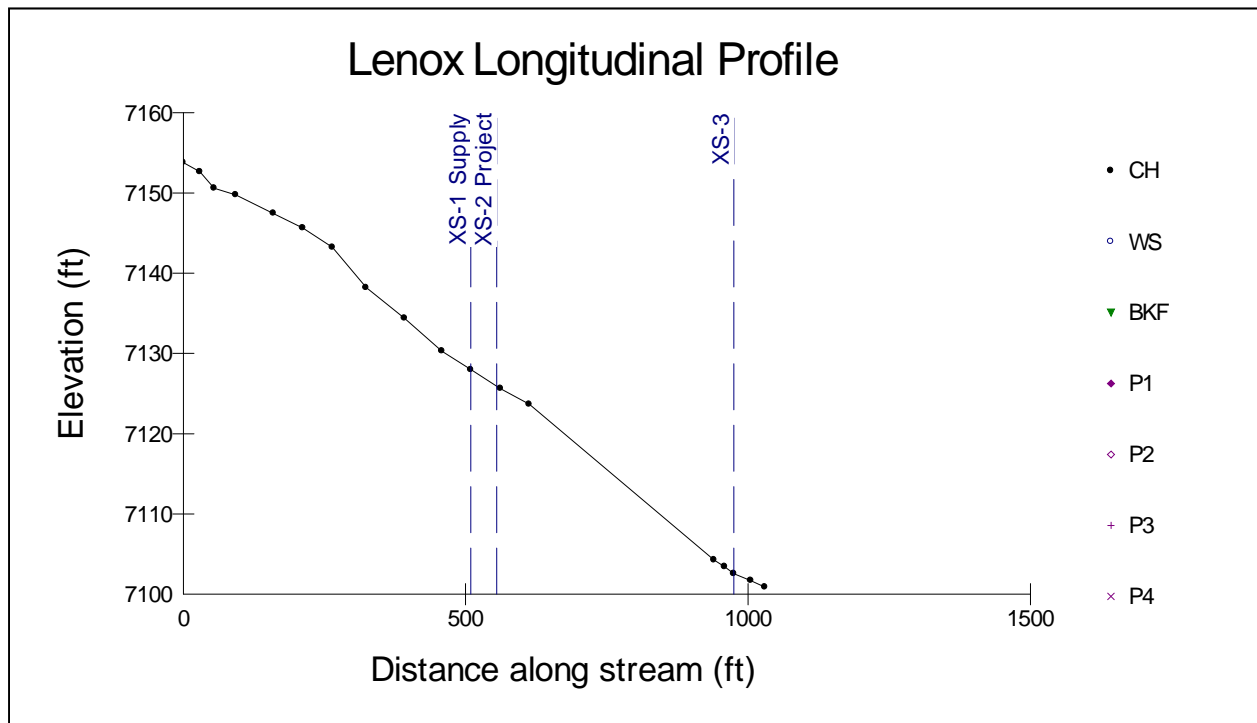
Figure 20. Longitudinal profile of the surveyed reach at the mouth of the Lenox watershed, just upstream of the Wupatki Trails neighborhood. Channel slopes average 4.5%.

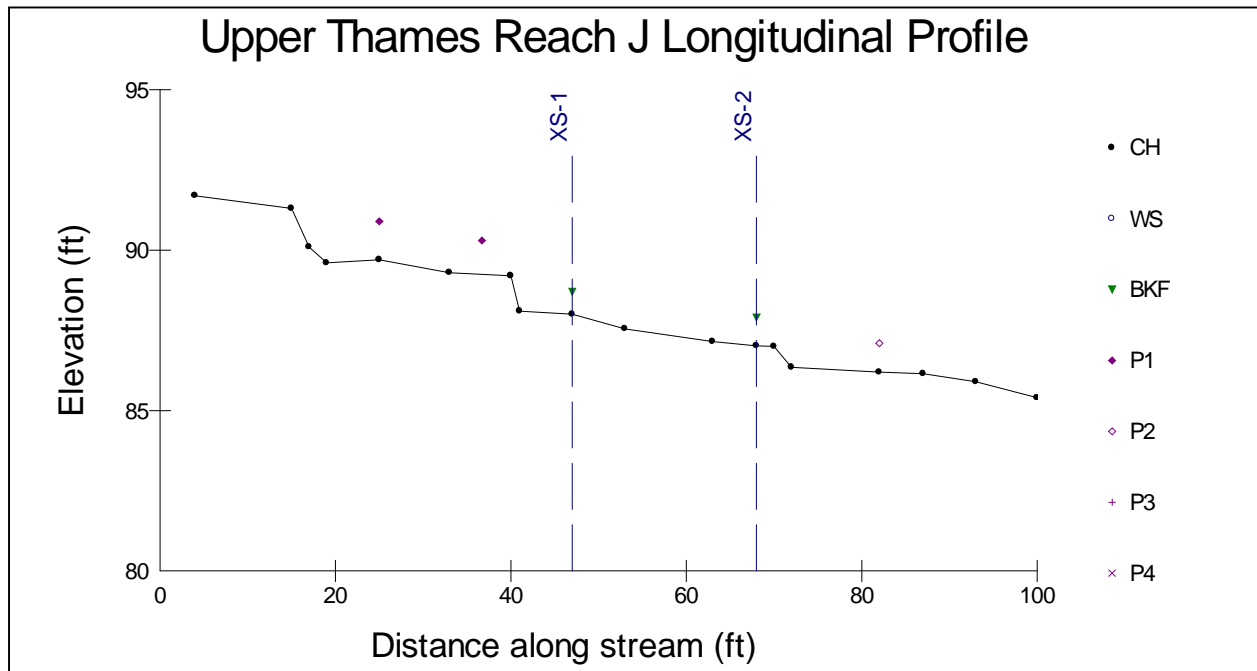
Figure 30. Longitudinal profile of the surveyed reach, channel slopes average 7%.

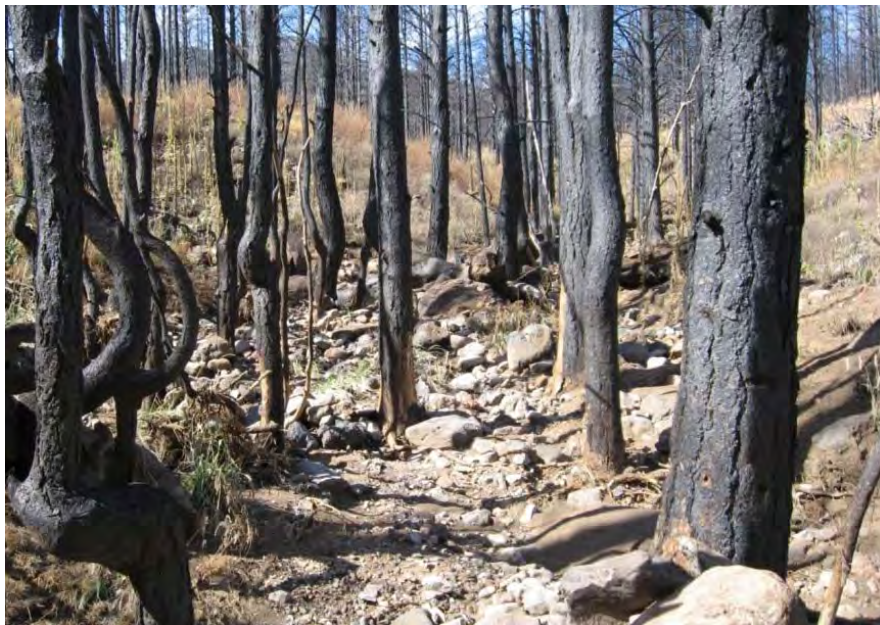
Figure 34. Representative photograph (ID114) of the lower gradients found in the Lower Thames watershed

The channel is holding together fairly well in this location, however the presence of trees and other obstacles within the channel is decreasing the capacity of the channel.

This portion of the Thames watershed has lower gradients and is more prone to deposition than erosion. The stability of the channel is poor due to the tendency of the channel to aggrade and migrate laterally. The streambank erosion rate is 0.18 tons/yr/ft . At the survey location the valley is a Type III. The channel slope within the survey is 3 % with a bankfull cross-sectional area, determined by local curve, of 17.5 ft^2 . The 1.7 mi^2 watershed has a bankfull discharge of $12.4 \text{ MDF}/32.7 \text{ IM cfs}$ at the survey location. The combined bedload and suspended load transport capacity of the current “F” channel is 77 tons/yr . It is expected that the historic or restored “B” channel would have a transport capacity of 75 tons/yr , a 3% reduction over the current condition.

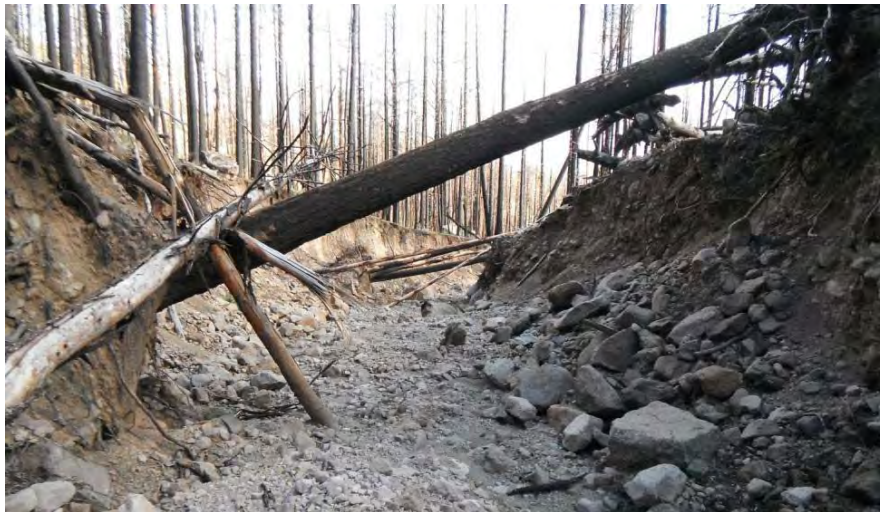
Figure 39. Photograph (ID145) of the deeply scoured portion of Peaceful Way taken in the upper portion where the steeper slopes flatten

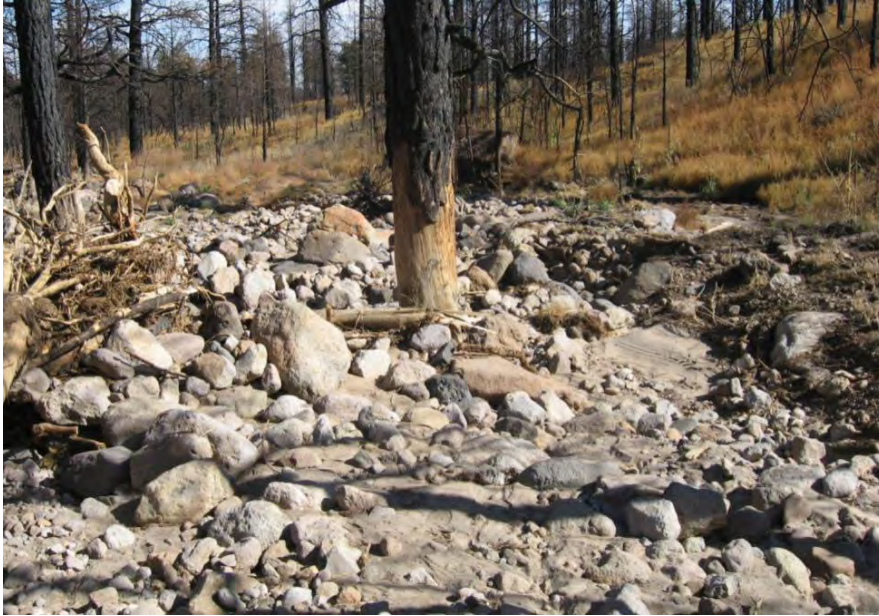
Figure 47. Representative photo (ID120) of the breadth of channel in the lower reaches of the Peaceful Way watershed

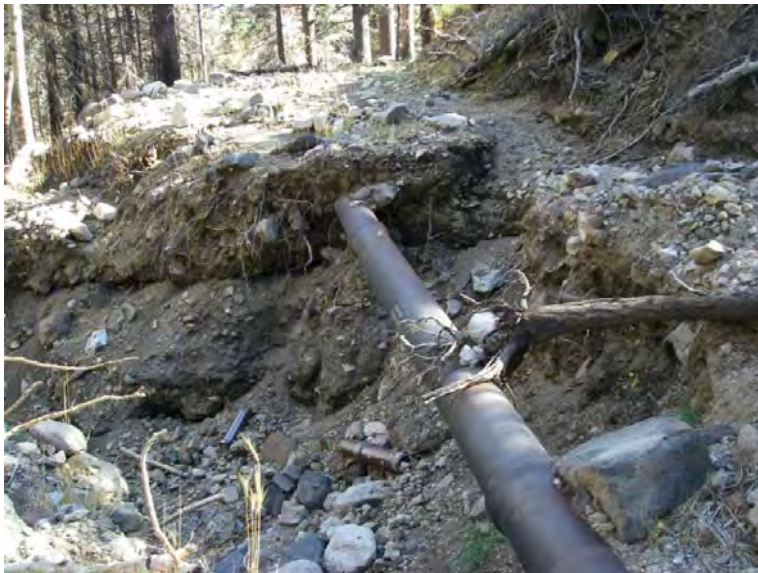
Figure 52. Photo (ID54) showing the degradation of the steep upper reaches of the Copeland watershed at the Waterline Road

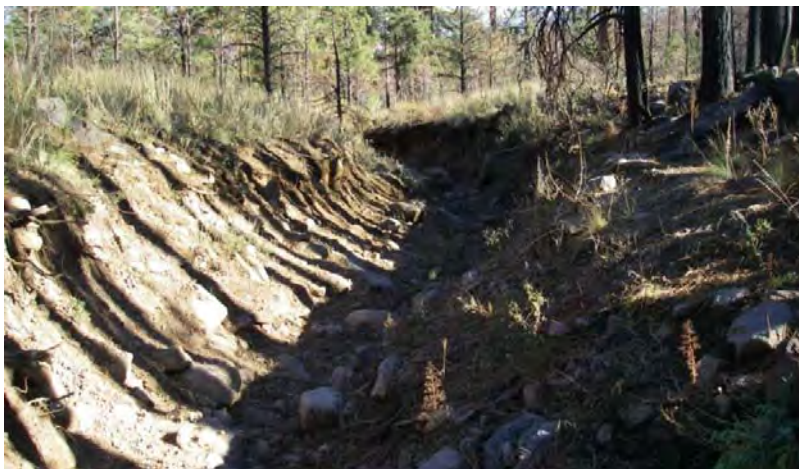
Figure 53. Representative photo (ID60) of the incised channels in the upper reaches of the Copeland watershed

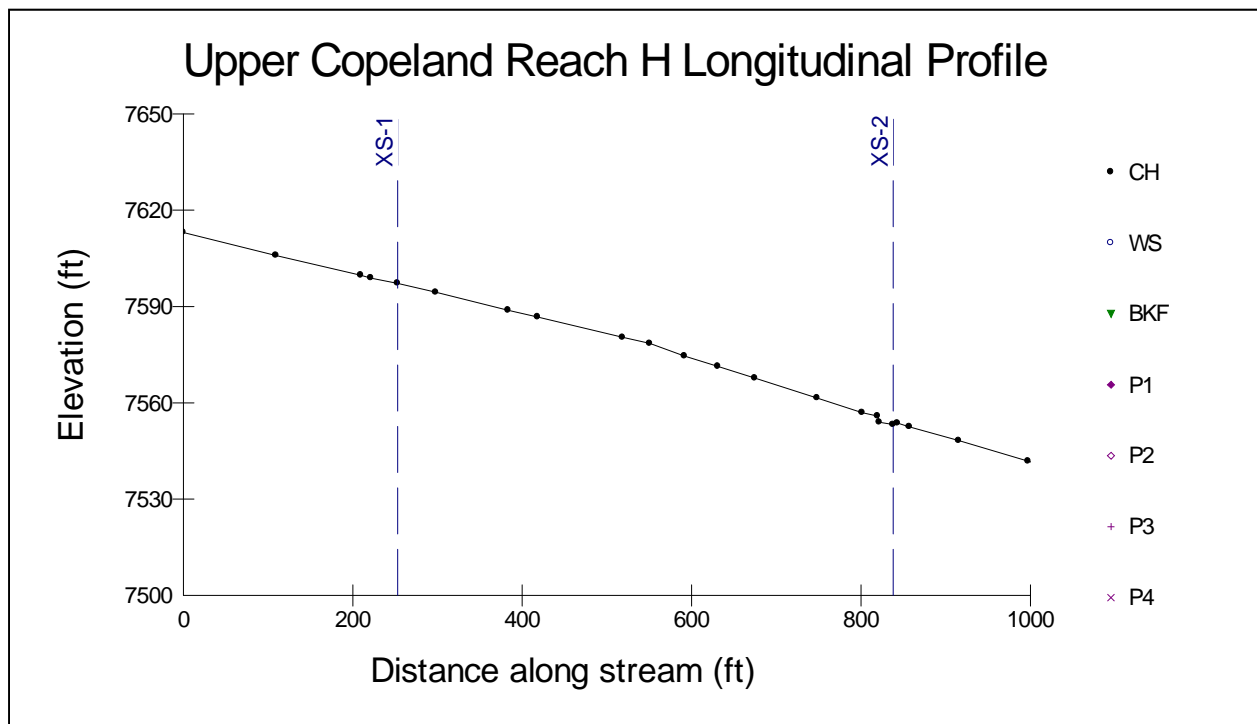
Figure 55. Longitudinal profile of the surveyed reach, channel slopes average 6%.

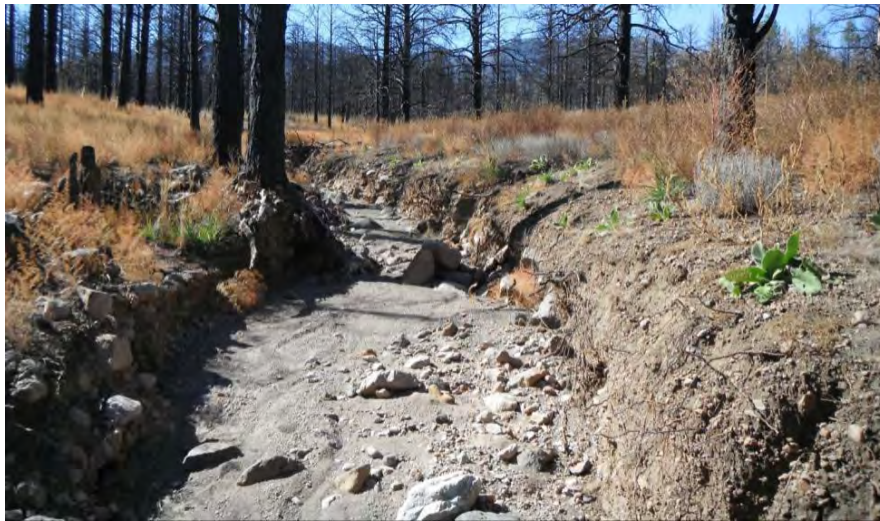
Figure 59. Representative photo (ID105) of the incision occurring through the middle-section of the Copeland watershed

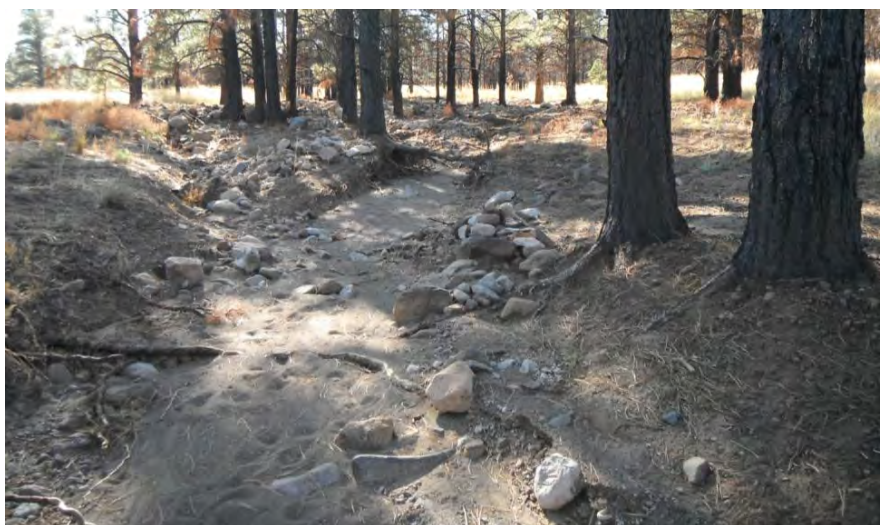
Figure 60. Representative photo (ID106) 'D' channel found in the lower reaches of the Copeland watershed

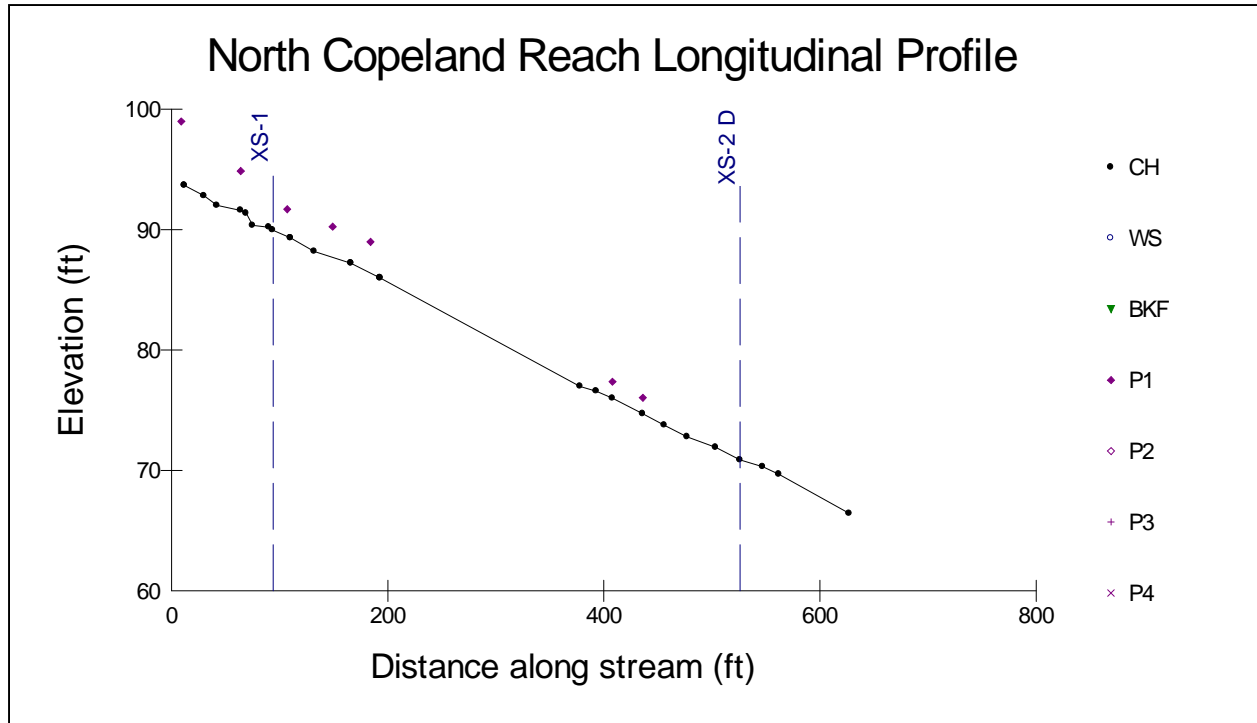
Figure 61. Longitudinal profile of the surveyed reach, channel slopes average 4.2%.

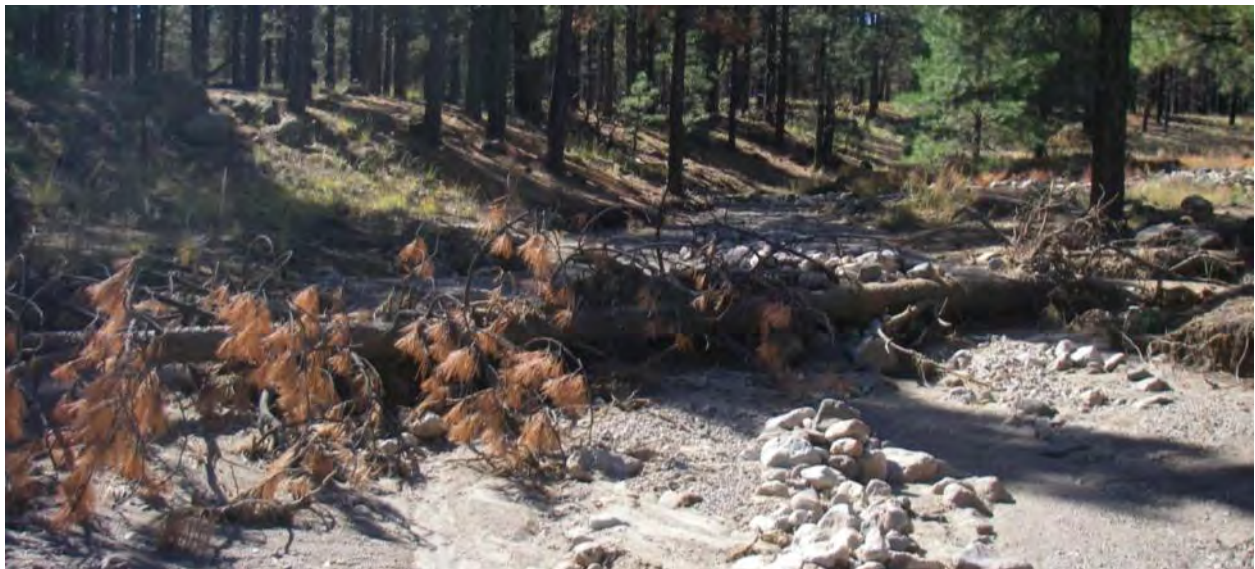
Figure 66. Photo (ID127) looking upstream showing sediment storage behind a temporary log jam

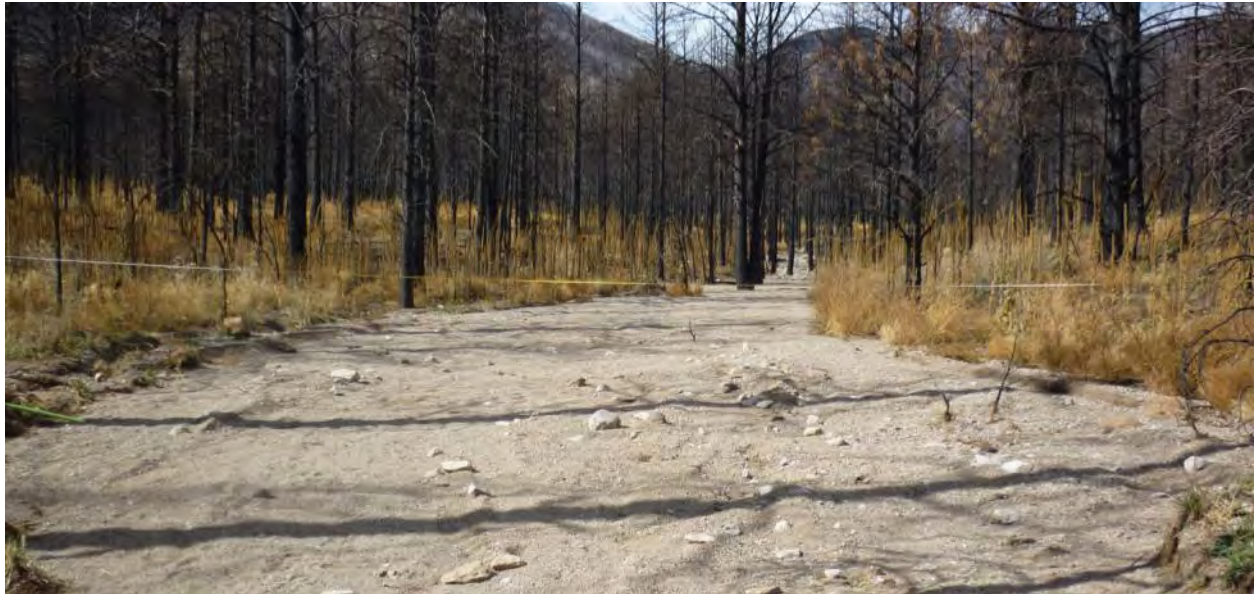
Figure 71. Representative photo (ID195) showing the 'D' channels found in the upper Rope Arabian watershed

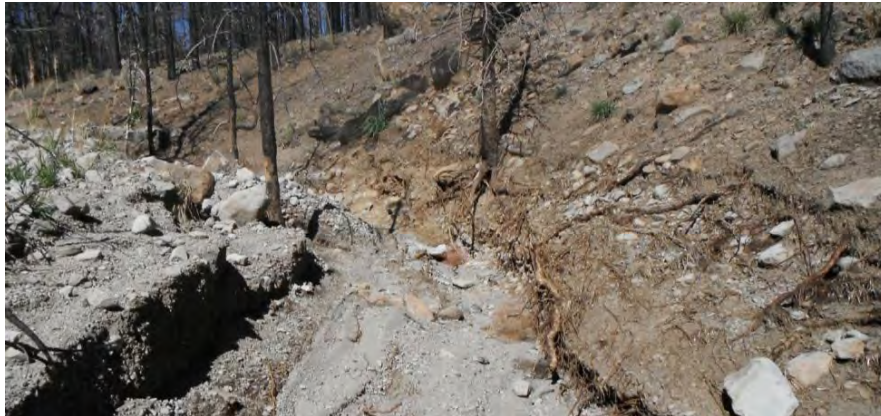
Figure 75. Photo (ID163) showing scour through previous aggradation in the upper portion of the Rope Arabian G watershed

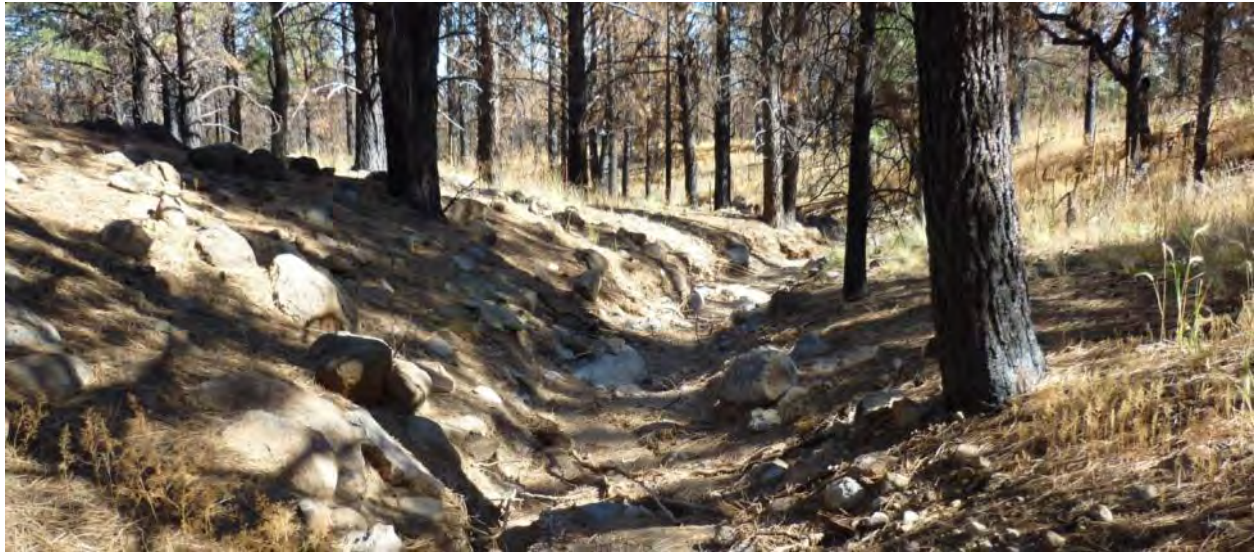
Figure 81. Representative photo (ID178) of the fairly stable channels found throughout the lower reaches of the Rope Arabian watershed

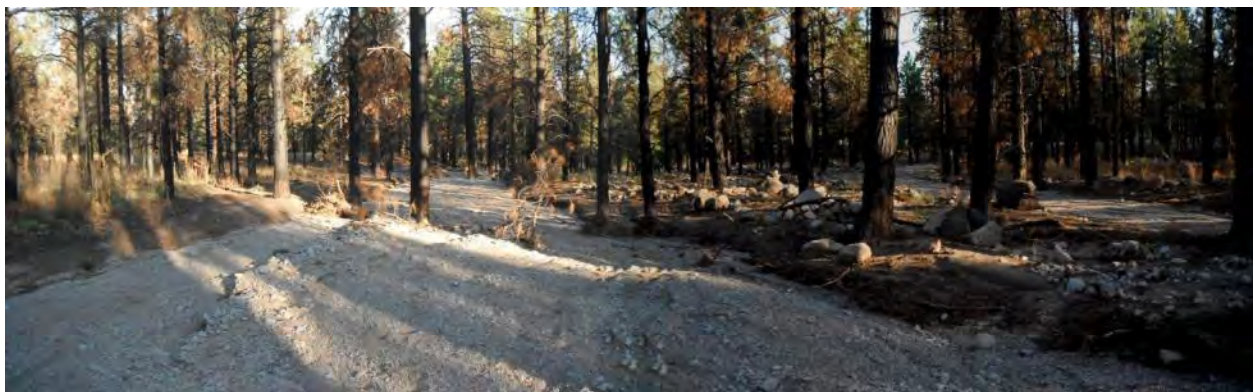
Figure 82. Representative photo (ID38) of the spreading out of the channel in the lower reaches of the Rope Arabian watershed

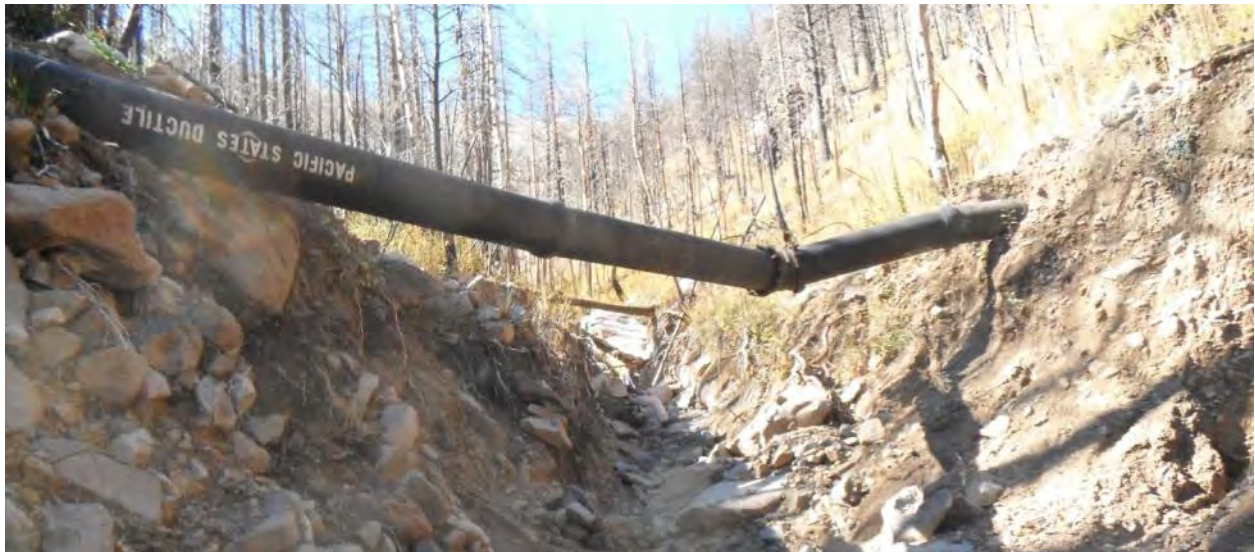
Figure 87. Representative photo (ID7) of the highly incised channels found in the steeper reaches of the upper Siesta-Paintbrush watershed

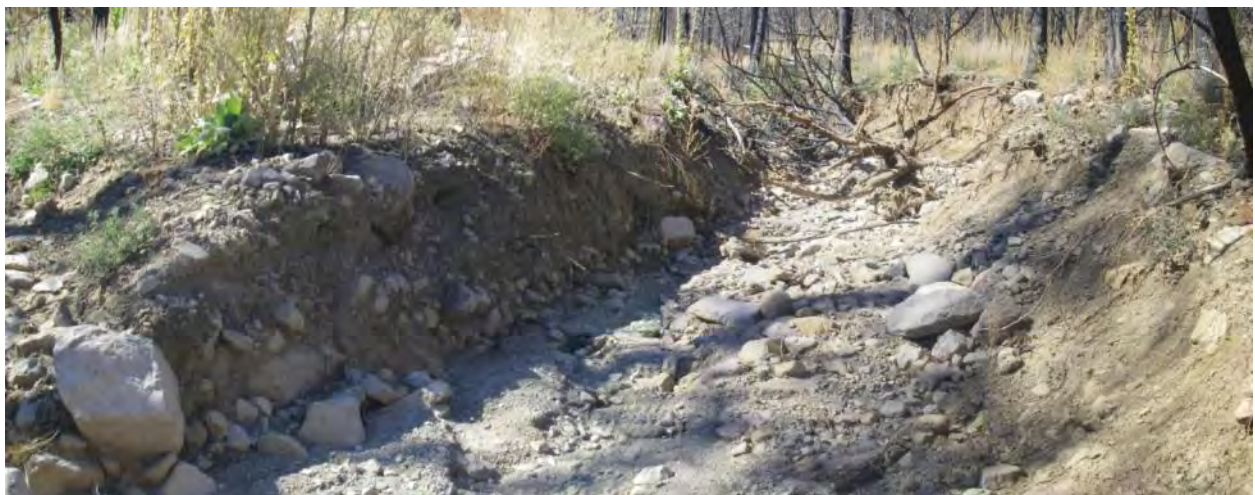
Figure 88. Representative photo (ID6) of the incised channels found in the less steep reaches of the upper Siesta-Paintbrush watershed

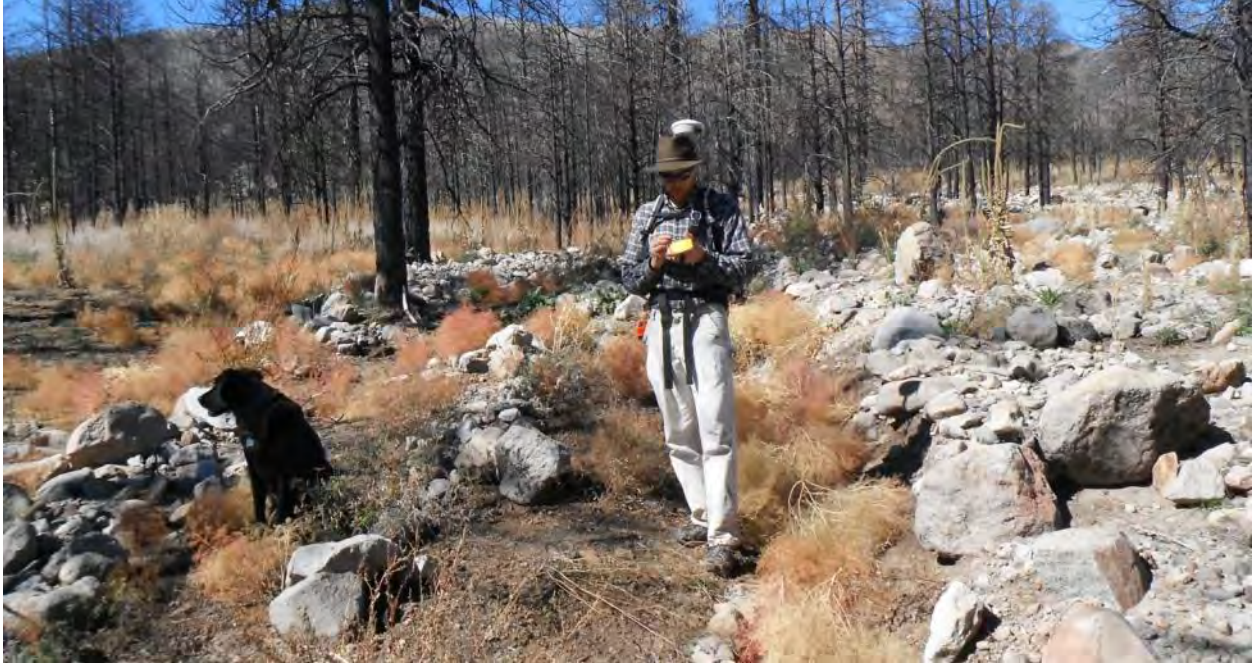
Figure 89. Representative photo (ID4) of the spreading of sediment where gradients are lower

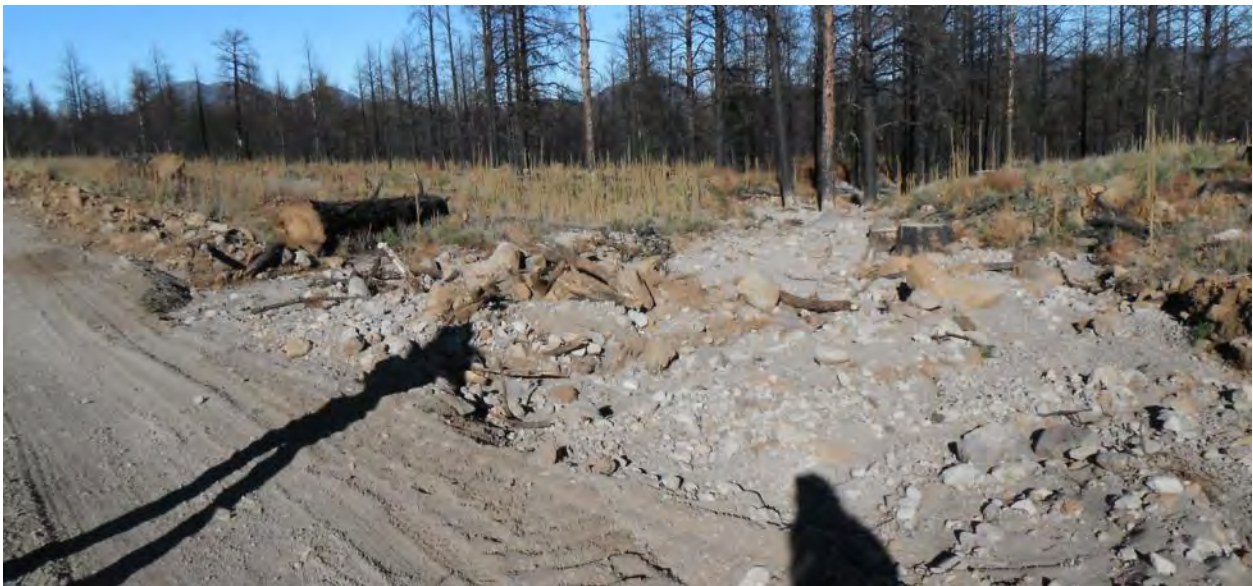
Figure 90. Representative photo (ID11) of the 'D' type channels found near FR420

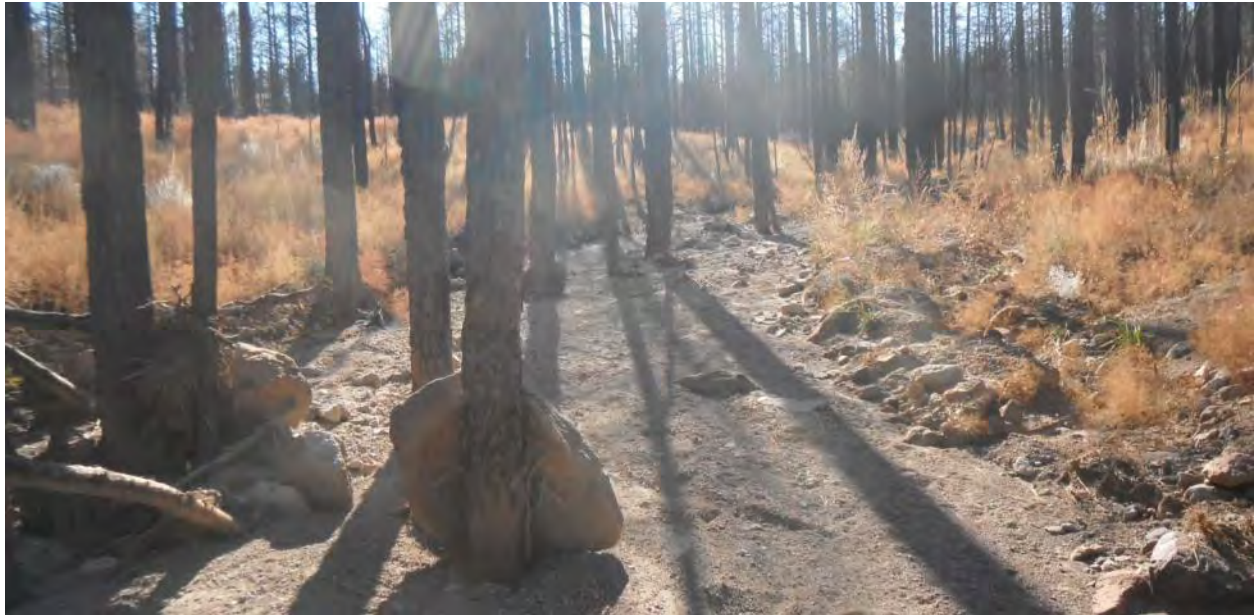
Figure 95. Representative photo (ID24) of the stable channels found in the mid reaches of the Siesta-Paintbrush watershed

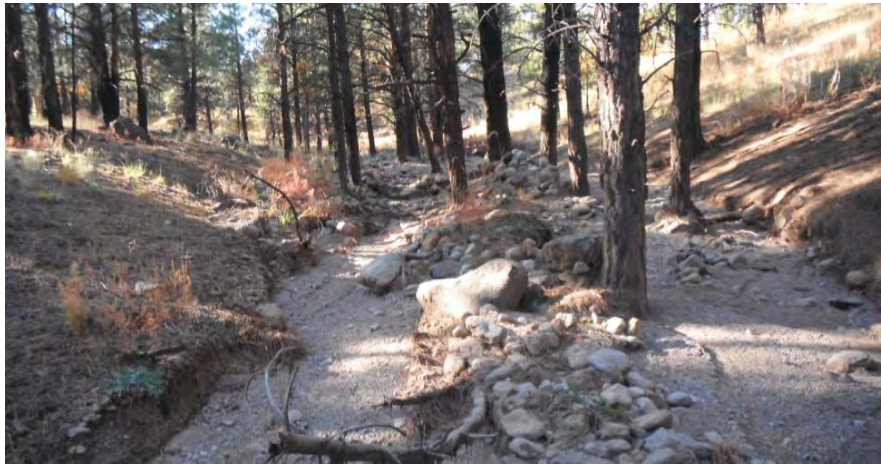
Figure 100. Representative photo (ID27) of the aggradation in a previously incised channel

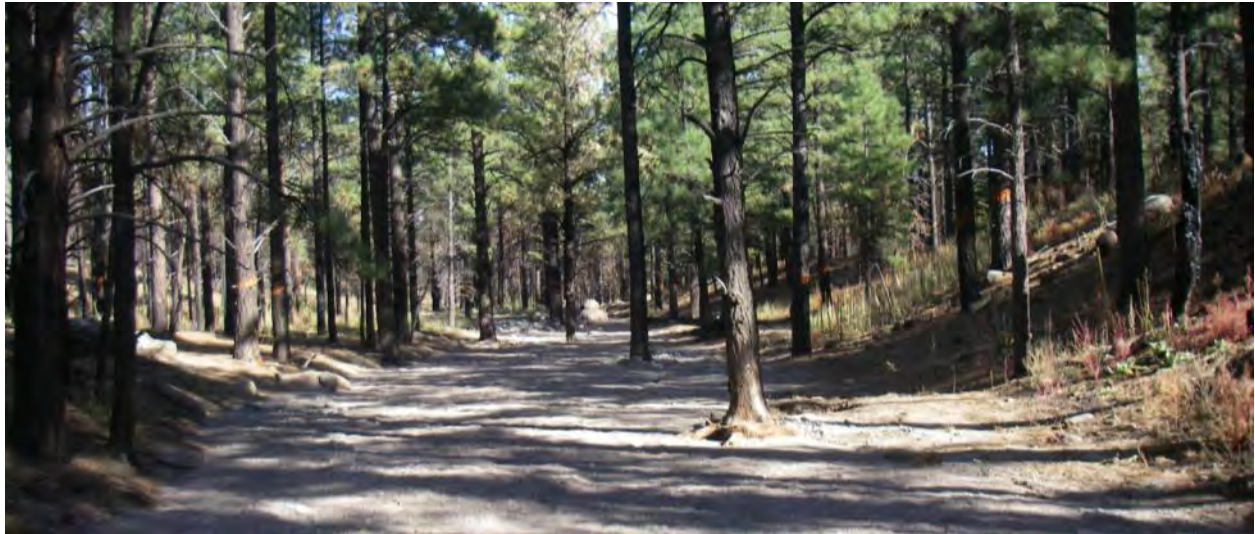
Figure 105. Representative photo (ID95) of the wide spread-out channels found in the lower reaches of the Paintbrush-Siesta watershed

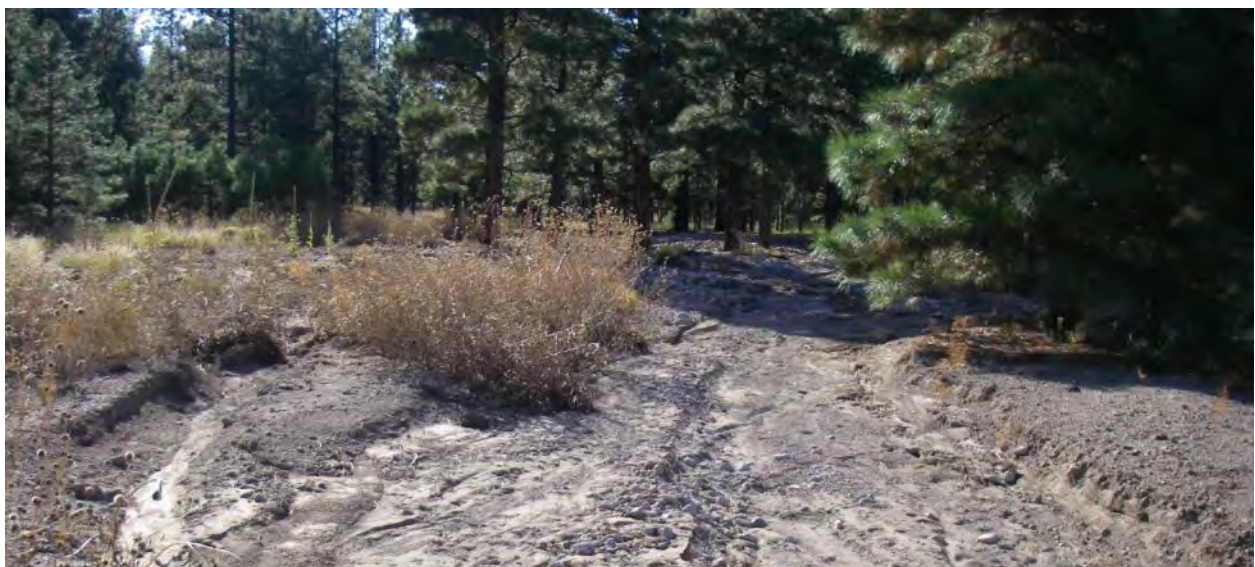
Figure 106. Photo (ID96) showing the unconfined flows as it approaches the neighborhood
